Liquefaction Damage of Harbor Facilities during the 1995 South Hyogo Earthquake

The 1995 South Hyogo Earthquake took several thousand of lives and destroyed momentarily infrastructures which were designed to perform for a long time. Particularly damages of harbor facilities including Kobe Port were almost completely destroyed. Geological hazards occurred on a large scale at many areas too.

This paper describes results of field surveys about damages of harbor facilities and liquefactions mainly in Kobe City, and discusses some about the mechanism and the countermeasure.

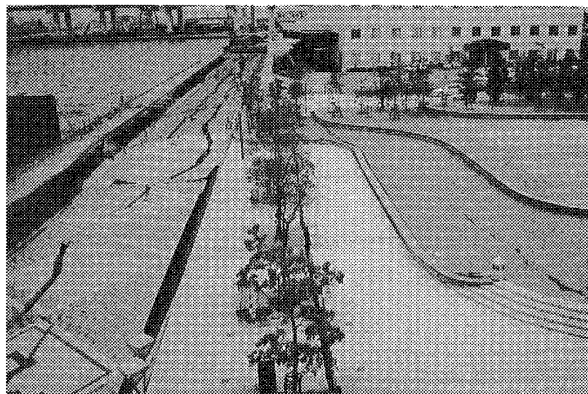
Photo 1 shows damage of the north caisson quaywall in Rokko Island. At the ground on the right side some cracks run on the surface. A lateral flow of ground is occurred due to liquefaction.

Photo 1 Lateral flow (taken on Feb. 4).

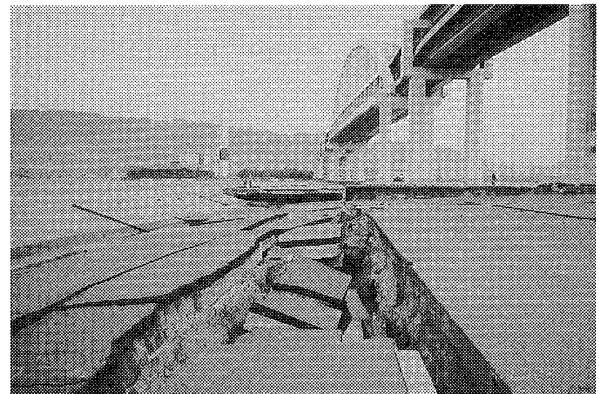
Photo 2 shows a slide of caisson quaywall to the

sea side and a scene of destruction of quay surface due to liquefaction. Under pavement a decomposed weathered granite, called "Masado", is accumulated. This soil is colored light brown color and has a large cohesion. Inside, much sand boiling is spread over the surface.

Photo 2 Destruction of quay surface (taken on Feb. 4).

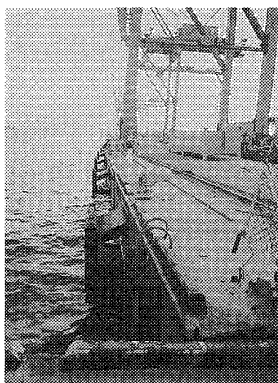
The moving to the sea side of the east caisson quaywall in Port Island is shown in Photo. 3. The front line of quaywall had moved all alike. From this moving style point of view one may say that the quaywall had been moved by the main shock of this earthquake.

Photo 3 Moving of caisson quaywall (taken on Feb. 12).

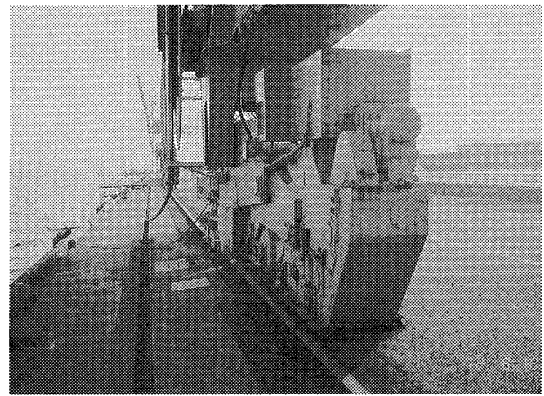
It can be seen in Photo. 4 that the leg of gantry crane is dropped from the driving rail.

Photo 4 Damage of gantry crane (taken on Feb. 12).

Many harbor facilities have got grave damages by this earthquake. Because Kobe City is a harbor town in particular, this earthquake caused many influences on a social and a economical activity. The gantry crane on caisson quaywall was almost completely destroyed as shown in Photo. 4, and this damage have made almost loading and unloading

works to be impossible for a long time.

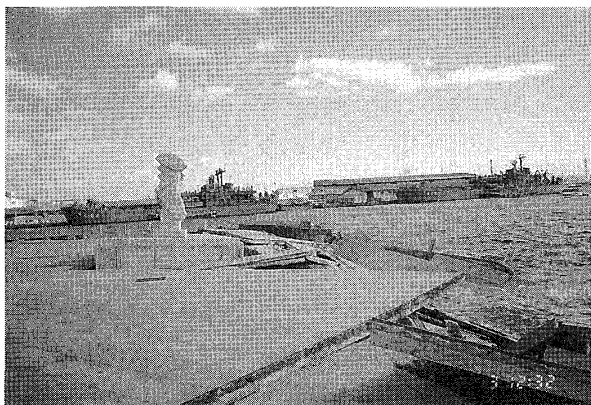
Photo 5 shows the destruction of bulkhead on the south side in Meriken Park. This place is considered as a recreation spot for citizens particularly for

Photo 5 Destruction of bulkhead (taken on Feb. 3).

visitors. The symbol of a sightseeing in Kobe had completely damaged too. The ground under concrete pavement slab has undergone a surface soil Stabilization, because the upper layer under crushed stones is white and is self-supported. it can be regarded that the lower layer had been.

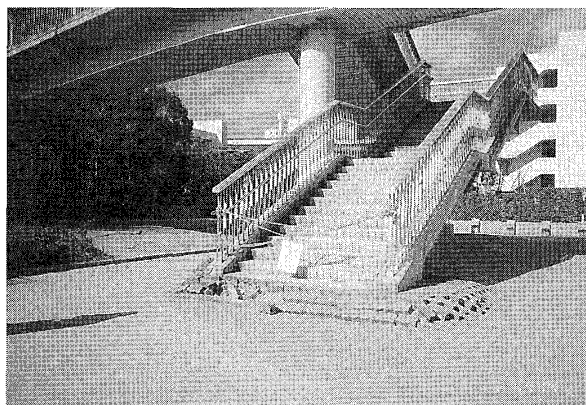
Photo 6 shows a condition on which liquefied the step of pedestrian bridge rised due to settlement. This location is about 200m from one of Photo. 5, and the ground have subsided about 20cm. From this view point one may say that the whole area have subsided.

Photo 6 Settlement and rised pile (taken on Feb. 3).

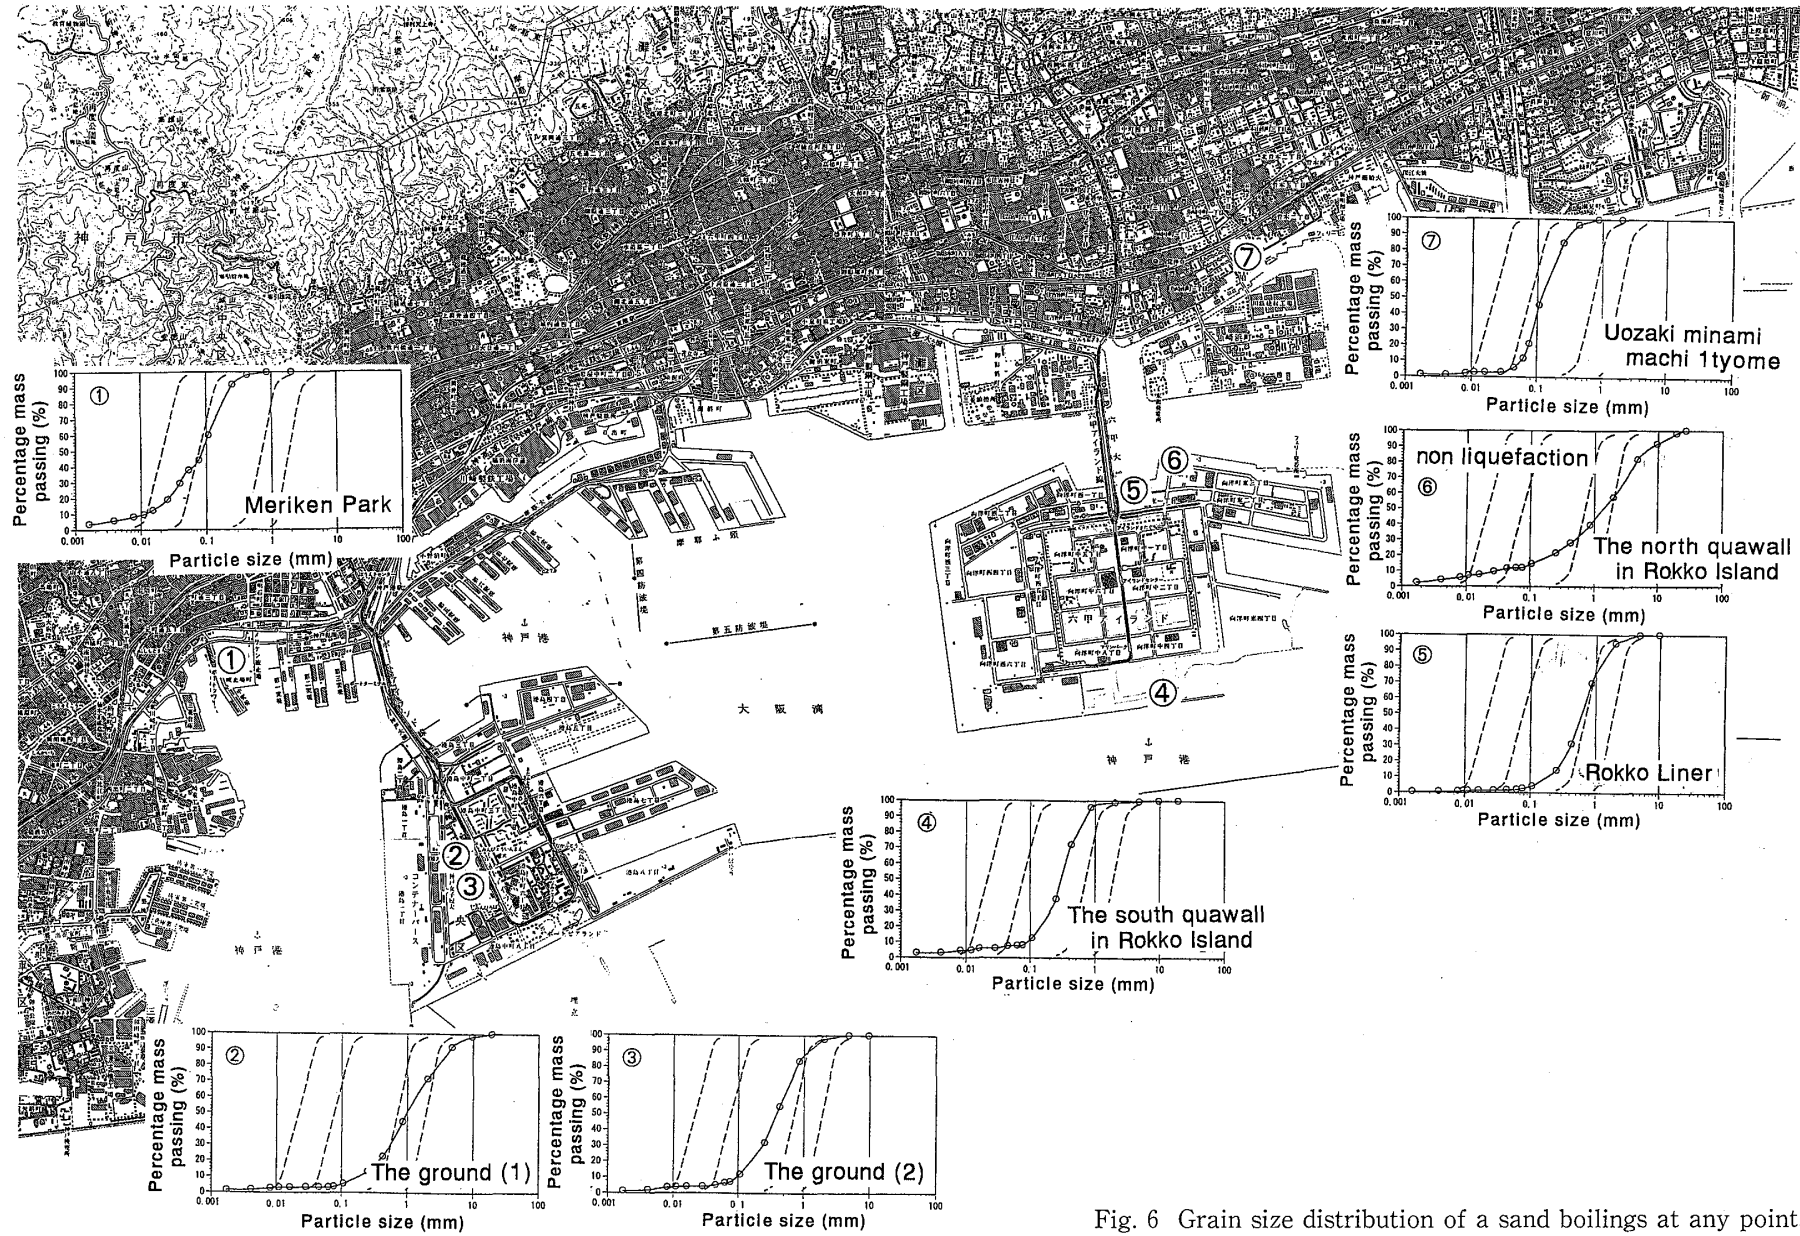
Fig. 6 Grain size distribution of a sand boilings at any point.

Results of grain size analysis of sand boiling sample obtained from in situ are shown in Fig. 6. Because sand boiling is a soil which spouted and accumulated above the ground with waters, we must be care that the grain size distribution for laboratory test is different from which in the field.

The No. 2 sand boiling that picked up at the school ground in Port Island includes some big gravels with the biggest diameter of 19mm of the particle size. This fact indicates that a very large water pressure has occurred when the earthquake was started.

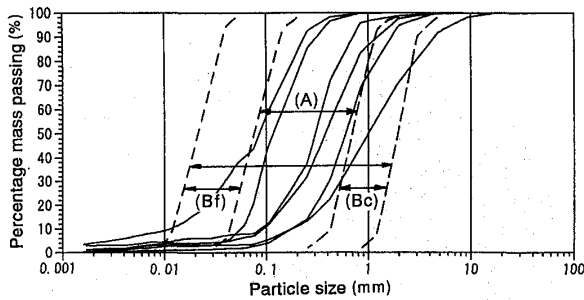
Fig. 7 Grain size distribution of a sand boiling.

The grain size accumulation curve shown in Fig. 7 includes all curves shown in Fig. 6 can be used as a judgement criterion of liquefaction³⁾ as established by the Harbor Office, the Ministry of Transport. If a curve is included within the range A, the soil is judged as a soil with a big possibility of liquefaction occurrence. If a curve is included within the range B_f or B_c, the soil is judged as a soil with possibility of liquefaction occurrence.

As a result of laboratory test for the sand boiling, it can be regarded that all soils are included within the range A.

In Fig. 7, the No. 6 soil at the north quaywall in Rokko Island is not a sand boiling. The grain size accumulation curve is distributed in wide range. So far as the grain size distribution is concerned, it can be used in judging whether liquefaction may

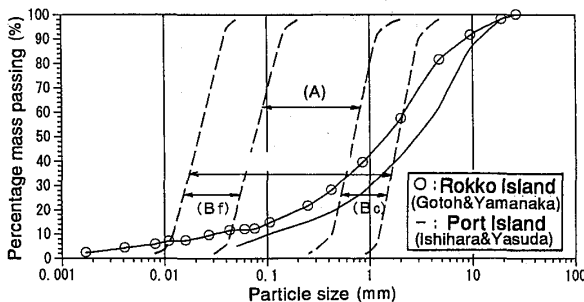
Fig. 8 Grain size distribution of a reclaimed material (comparing our data with the data of K. Ishihara & S. Yasuda⁴⁾).

A decomposed weathered granite originated at Rokko Mountains have been used in reclaiming artificial islands like Rokko Island and Port Island. As Fig. 8 indicates, this soil has a good grain size distribution and has a cohesion to some degree, and it has been said as a suitable soil for reclamation purposes material because it has a good resistance against liquefaction. Eventhough liquefaction have been occured widely in these artificial islands. We can say that some analysis are left for future.

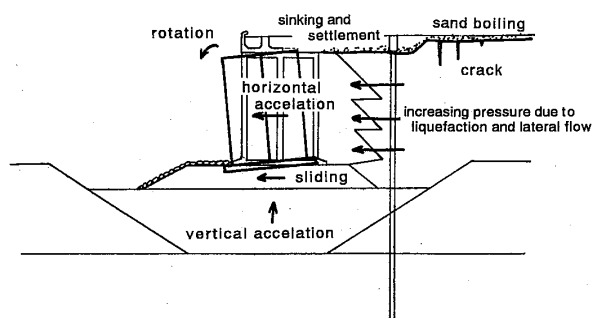
Fig. 10 Estimated diagram for the damaged condition.

An estimated diagram for the damaged conditon is shown in Fig. 10. As a result of our field surveys, we noticed that most of the caissons were bent forward the sea side, and uniformly moved forward. Because of the moving of the caissons, the behind ground had sunk about 1~2m. And sand boilings were accumulated on the subsided ground and the behind area from the ground.

- At first the caisson is lifted by the seismic acceleration which was beyond the expectations, which is in the vertical direction in this case, the friction force between the base of the caisson and the foundation riprap is lost, and the caisson is moved in forward direction due to a active earth pressure of the behind reclaimed soils.

- Because of the moving of the caisson and occurrence of the liquefaction, the behind ground

flows in lateral direction and some cracks occur in the ground.

On the other hand, it may be that the caisson was moved by the increasing pressure due to the liquefaction and the lateral flow. But the seismic acceleration of this earthquake is very large, and is a direct type earthquake which occurs in a short period of time. By considering the appearance process of liquefaction, it is difficult to think that the pore pressure rises at a short time like this shake and the liquefaction occurs later. Therefore it seems reasonable to suppose that the most important external force, which moved the caisson, is the inertia force due to the seismic acceleration.

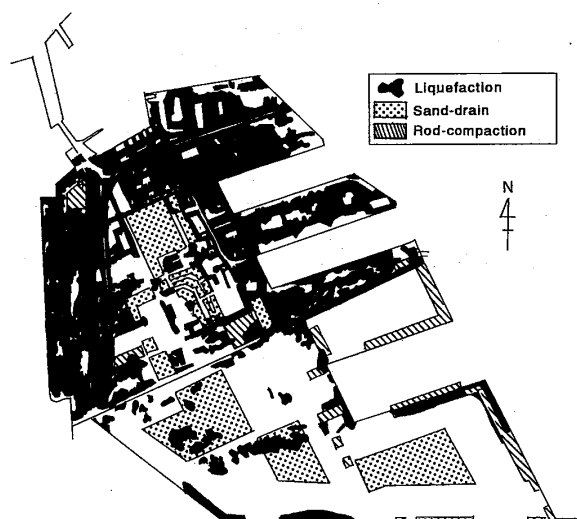
Fig. 11 Distribution of liquefaction in Port Island.

Figure 11 shows the relationship between the area of these countermeasure methods⁶⁾ and the liquefaction distribution area⁷⁾ based on the survey of the Geographical Survey Institute, Ministry of Construction. In areas which constructed by the rod compaction method as a liquefaction countermeasure, there is few area of liquefaction, this effect is obviously. And in the area which done by the sand-drain method as an accelerated consolidation method, it is noticed that there is some effect of liquefaction countermeasure. On the other hand, in area of no liquefaction countermeasure liquefactions widely occurred, from here we can observe the effect of these soil improvement

methods and techniques and their importance in liquefaction reduction.
