## The July 1997 Landslide Disaster at Harubun, Sasebo, Japan

Keinosuke GOTOH and Minoru YAMANAKA

Faculty of Engineering, Nagasaki University  
Bunkyo-machi, Nagasaki 852-8521, Japan

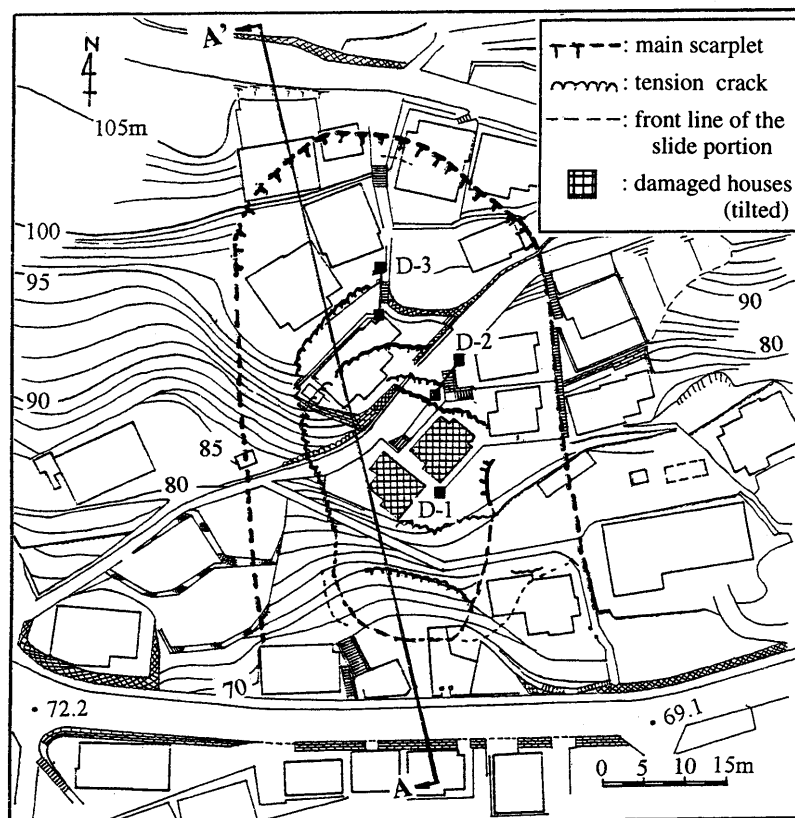
Fig. 2. Outline of the landslide (Modified after Nagasaki Pref., 1997).

that the surface block moved. The landslide was estimated to be about 30m long, and the crack only 20cm wide. At first it was believed to be a comparatively small-scale slide, but further movements occurred in relation to continuous rainfall. As a result, the local government called for evacuation from some houses located on the moving mass, and emergency works such as installing drainage pipes and spreading vinyl sheets to prevent the inflow of rainwater to some cracks were undertaken on July 8. On July 9 measurement of the slide distance was begun using an electro-optical method, and apparatuses to monitor land movement were set up at some points. On July 10, reconnaissance made by the Ministry of Construction confirmed that the moving mass was 40m wide, 60m long and 5-10m deep (Yomiuri Newspaper, 1997). The cracks widened, causing two houses that were displaced more than 1m after the rainfall of July 11 to tilt and come together, causing imminent collapse. Due to continuous land movement, several drainage drillings were conducted as a countermeasure on July 14.

The moving mass is shown in the plan in Fig.2 and in cross-section in Fig.3. The two houses damaged by this landslide are indicated by a hatched symbol. The 40m wide,

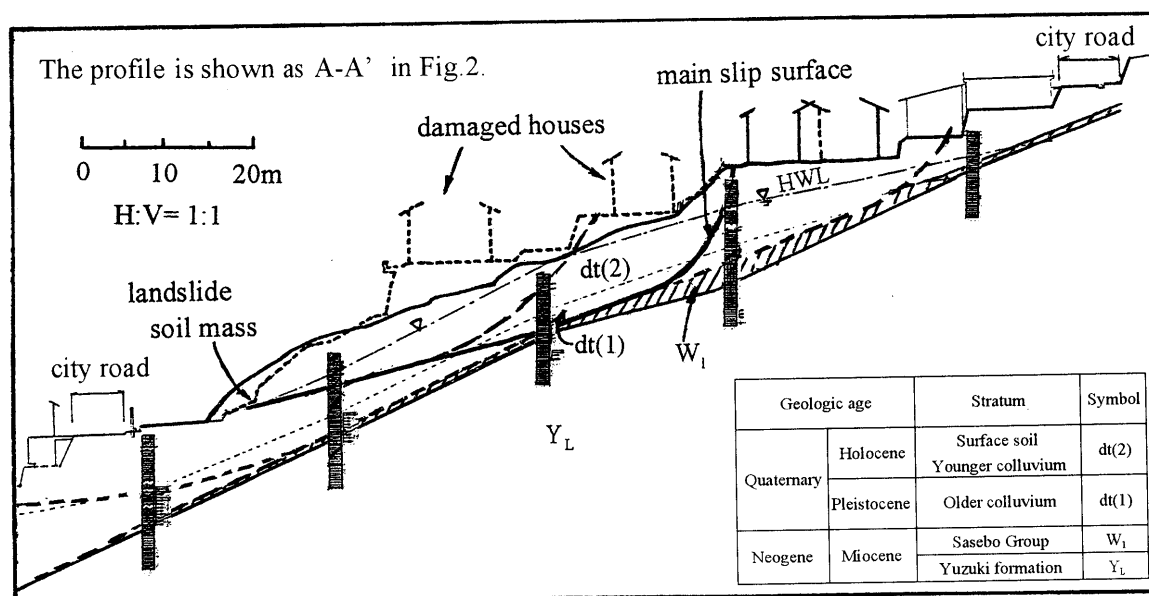
Fig. 3. Profile A-A' of the landslide (Modified after Nagasaki Pref., 1997).

60m long, 5–10m deep mass was classified as a shallow type landslide. The configuration of the topography, including the damaged area, is not clear because of the many houses present, but it seems to consist of a gentle concave slope.

The slip plane appears to be circular at the top and flat at the bottom (Fig. 3). According to Varnes' (1978) classification of slope movement, this landslide would be the slump type, a rotational landslide. As shown by the symbol dt(2), the top layer is composed of agricultural soil or soil fill added for the housing development. It is a cohesive, brownish soil containing large fragments of basaltic rocks that is soft and easily punched by a finger. The groundwater level is within the deposits shown in dt(2), 3 meters below ground surface. This was confirmed one month after the sliding.

Symbol dt(1) represents a cohesive colluvium soil, which may be reworked deposits of weathered Pleistocene sandstone

and shale, distributed below the ground water level. W<sub>1</sub> is a gravelly cohesive Miocene strata which is markedly weathered. It is about 0.4 meter thick, and is a confined aquifer. This thin layer may constitute the slip plane. Y<sub>L</sub> is a solidified deposits composed of chert, sandstone, and a thin coal layer with lignite. The horizontal distribution of these strata, it is not yet clear.

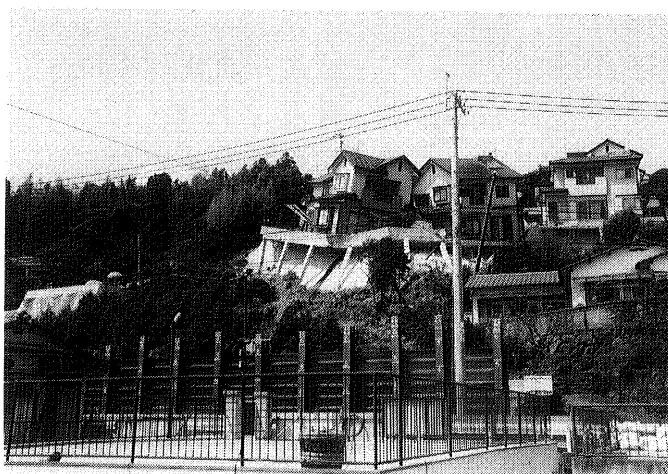
Photo 1 shows the two markedly tilted houses on the

Photo 1. Far view of houses tilted by the landslide (Photo July 19, 1997).

moving mass. The concrete block retaining wall that supported the damaged houses is cracked and broken into two parts. Below the wall, a temporary protection wall consisting of a steel sheet-pile was built to prevent further downward movement of the houses.

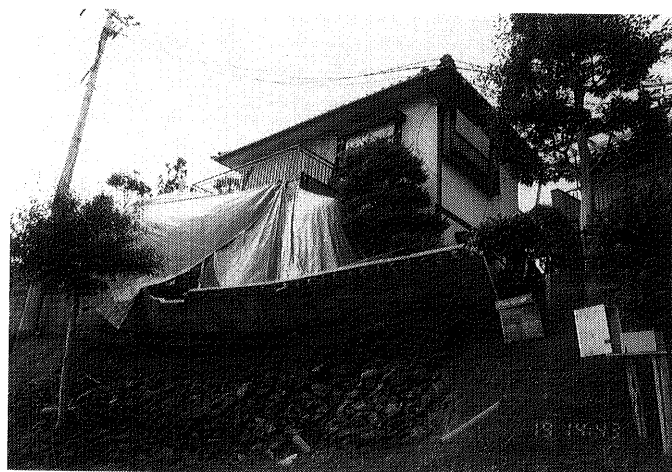
Photo 2. Collapse of a concrete block wall at the top of the landslide (Photo July, 1, 1997).

Photo 2 shows the collapse of a concrete block wall at the top of landslide where the main scarp appeared. A pole supporting power transmission lines and a wall have fallen forward and are seriously damaged. A crack about 30cm wide that occurred in the wall has been covered with vinyl sheets

as protection against seepage of rain water.

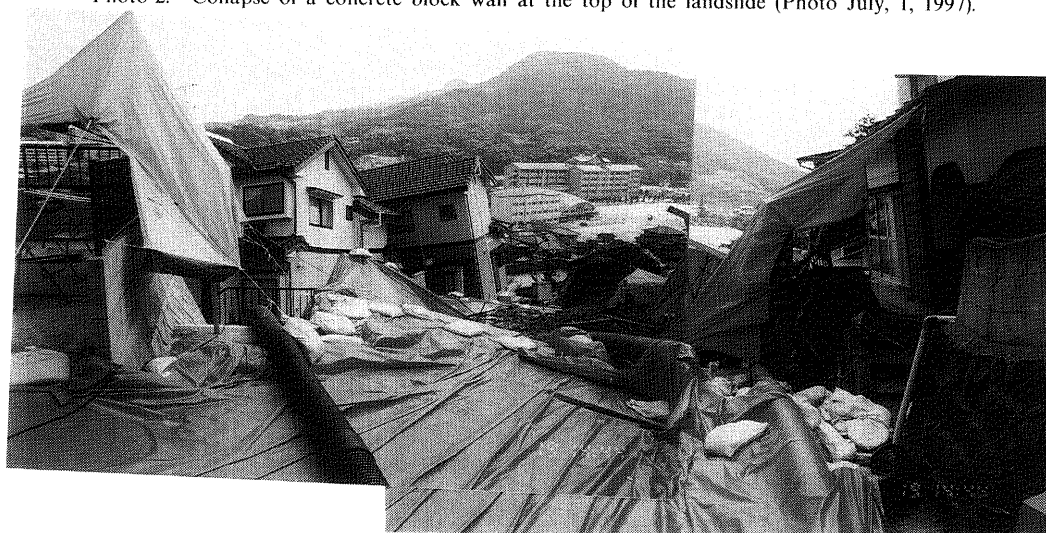
Photo 3. Close-up of the area damaged by the landslide (Photo July 1, 1997).

Photo 3 shows the inner appearance of the damaged area. Due to the settlement of fill, the two houses at the back have tilted until they are standing side by side. A large pipe was installed on this side to serve as a by-pass drain in place of the former waterway.

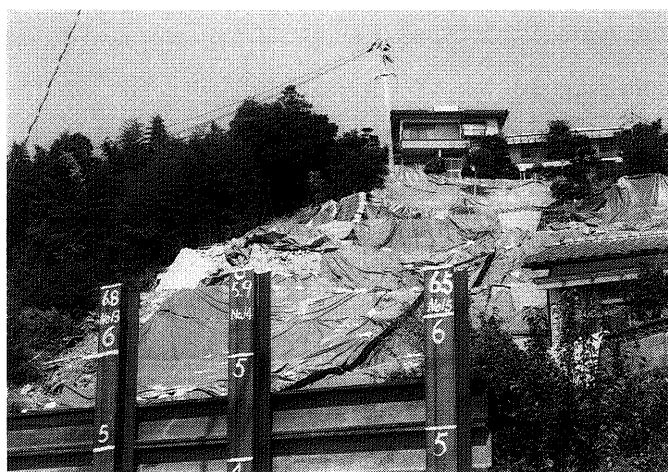
Photo 4. View from below of the collapsed-houses site (Photo Nov. 10, 1997).

Photo 4 shows an upward shot taken from the site of the temporary protection wall. Because of the danger of collapse, the two houses together with a third house located at an upper elevation, a total of three completely damaged houses.

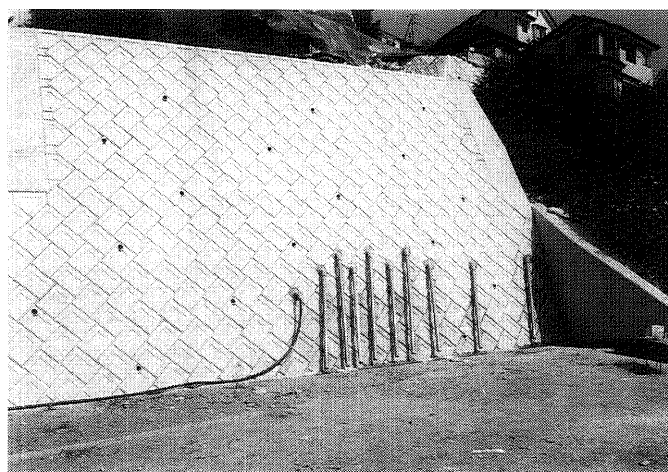
Photo 5. Location of drainage pipes (Photo Nov. 10, 1997).

Photo 5 shows drainage pipes installed to reduce the potential of sliding. Although there was fine weather after 9mm of rain on Nov.2, there was still some water outflow from the many drainage pipes.

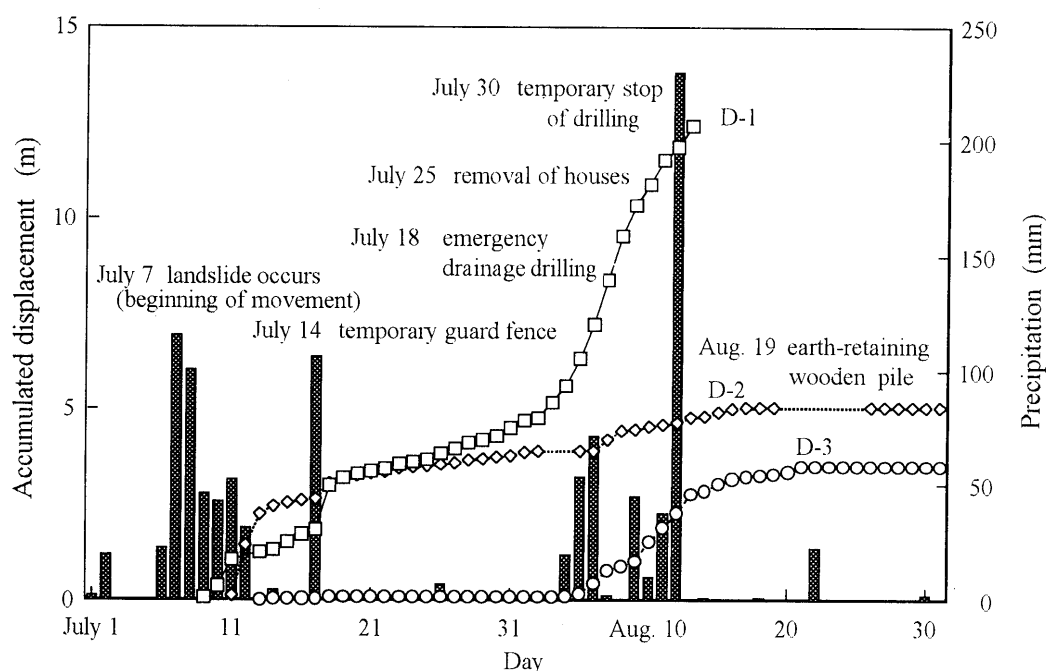
Fig. 5. Relationship between daily precipitation and displacement (Modified after Nagasaki Pref., 1997).

Figure 5 shows the precipitation before and after July 7, 1997 and the lateral displacement measured when the landslide occurred. Typhoon 9708 traveled north through the East China Sea and crossed north Kyushu on June 28, 1997, 116mm/day precipitation being recorded in Sasebo City (Nagasaki Branch of the Japan Weather Association, 1997). In early July, due to movement of the seasonal rain front from the Tsushima Island Strait to north Kyushu, rainfall became heavy, 410mm being recorded during the 6 days from July 6 to 12 (Nagasaki Branch of the Japan Weather Association, 1997). The maximum precipitation of 20.5mm per hour was recorded on July 7, the day the landslide occurred. Thus, an initiating cause is considered to have been this heavy rainfall. There was no rainfall after July 12.

Figure 5 also shows the accumulated displacement (D-1,

D-2 and D-3) of the sliding soil mass. D-1 is the accumulated displacement measured by the movable pile technique. D-2 and D-3 were measured by inner wire extensometers installed at the points shown in Fig. 2.

Displacement clearly was closely related to rainfall. Therefore it is necessary to protect against permeation by rainwater through dt(2) and to discharge the groundwater stored in dt(2).
