**Seismic damage assessment of mountain tunnel: a case
study on the Tawarayama Tunnel due to the 2016
Kumamoto Earthquake**

Xuepeng Zhang^{a,b} Yujing Jiang^{*a,b} Satoshi Sugimoto^a

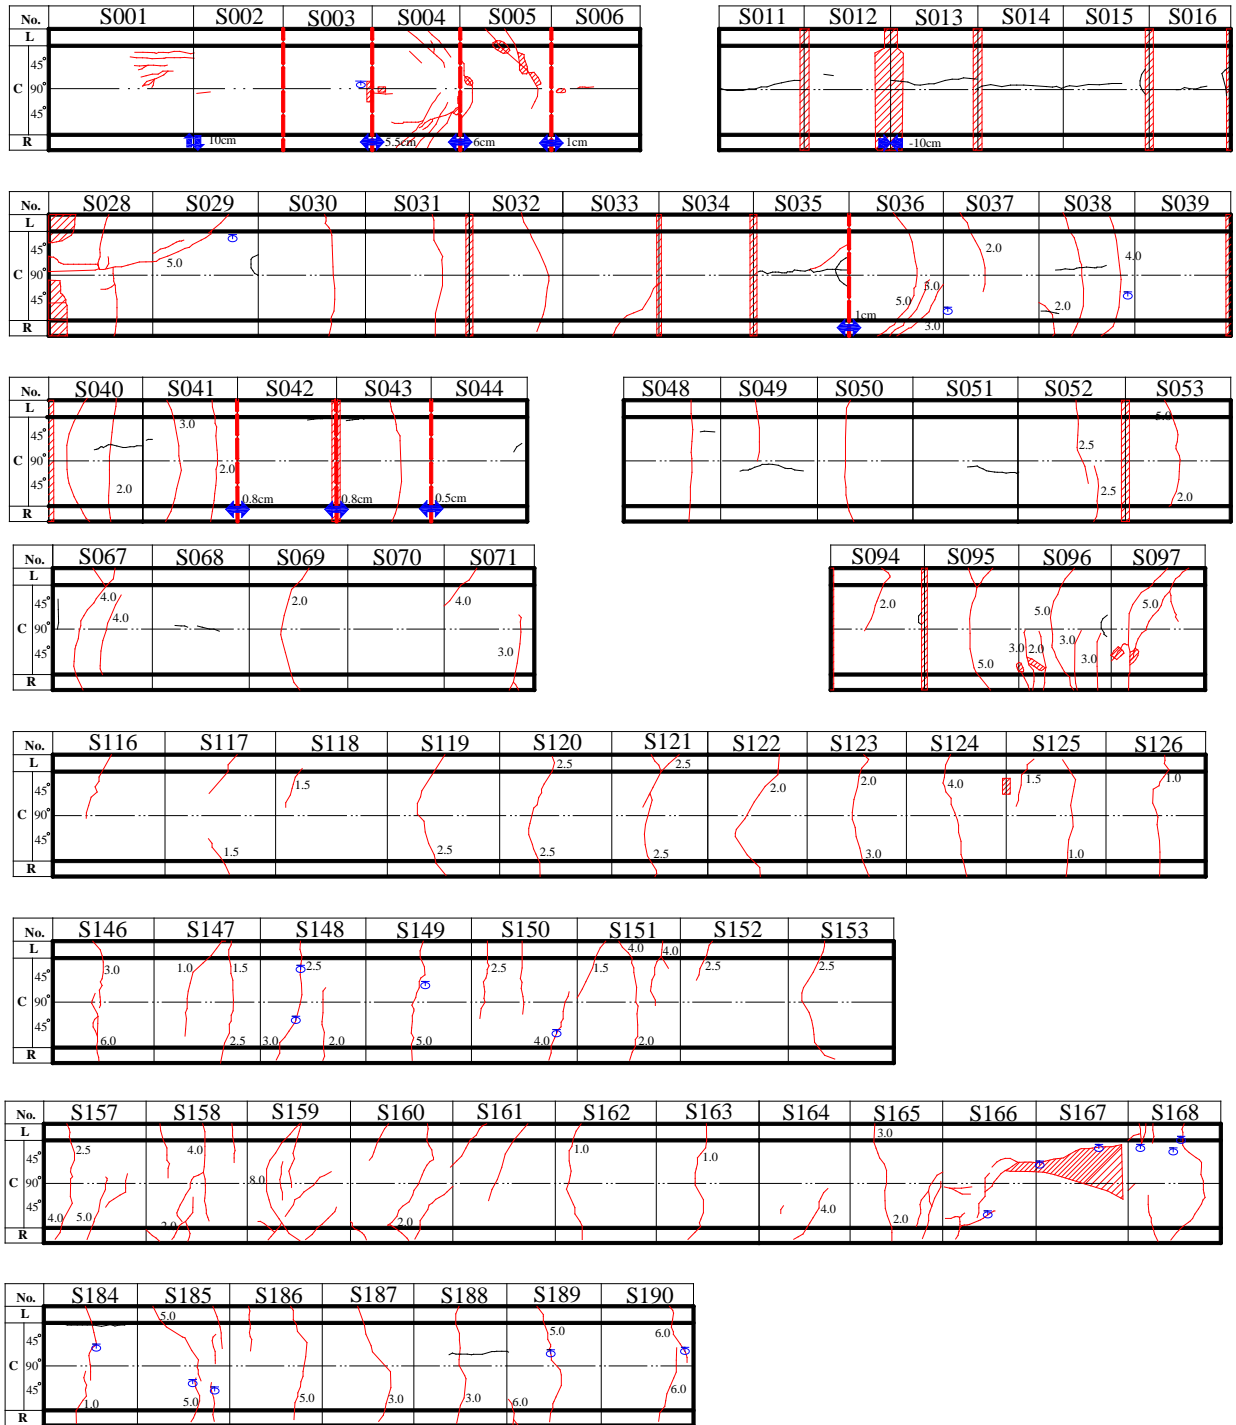
120 Among the seismic damages, lining cracks dominated with estimated number proportion of
121 66.5%, consisting of ring crack(23.9%), transverse crack(9.6%), longitudinal crack(13.0%)
122 and inclined crack(20.0%). Statistic and proportion of seismic damages to the Tawarayama
123 Tunnel by the 2016 Kumamoto Earthquake are shown in Fig.7. The lining cracks, especially
124 ring cracks, mainly occurred in the spans of S004~S005, S028~S053, S067~S071,
125 S094~S097, S119~S126, S146~S168, S184~S190(S is short for Span), with length of
126 783.2m(38.1% of the Tawarayama Tunnel total length 2057 m). Fig.8 shows sketch of the
127 seismic damages in these spans of the Tawarayama Tunnel.

Figure 8 Sketch of the severe seismic damages to the Tawarayama Tunnel by the 2016 Kumamoto Earthquake

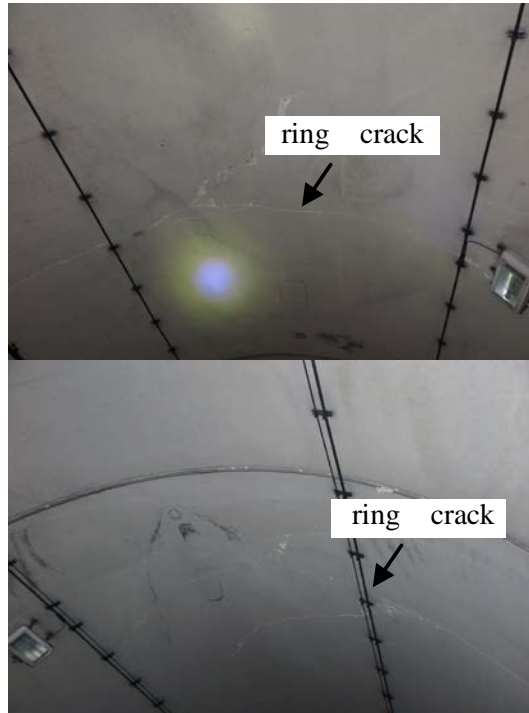
142 Ring cracks with maximum dislocation of 8.0 mm were the most frequently observed in the
143 Tawarayama Tunnel. Spans from S119 to S126 are representative examples(Fig. 9a). The ring
144 cracks can be further classified into two types: transverse ring cracks and inclined ring cracks.
145 Sketch and mapping results of these two types of ring cracks are shown in Fig.9b. Damage of
146 this pattern was also found in the Zipingpu Tunnel, the Longdongzi Tunnel and the Longxi
147 Tunnel built on the Chendu-Wenchuan Line in China following the 2008 Wenchuan
148 Earthquake(Li et al, 2012).

Figure 9 Ring crack of concrete lining. (a) ring crack in the **spans** from S119 to S126 in the Tawarayama Tunnel; (b) sketch and mapping result of ring crack

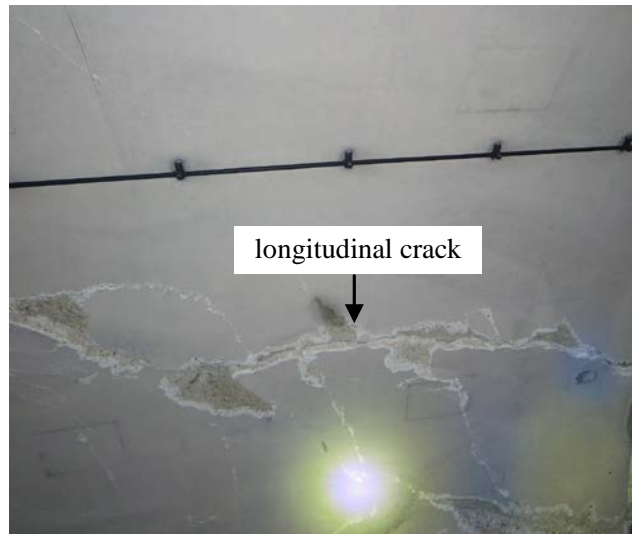
149 Pattern of longitudinal cracks of concrete lining was another severe one. They were much less
150 than ring cracks. Most longitudinal cracks occurred at the portal(S001) near the Nishihara
151 Village. Fig.10 illustrates longitudinal cracks occurred in the Tawarayama Tunnel. This
152 damage pattern can be further classified into three types: singular crack at the vault of the

153 crown, symmetrical crack and non-symmetric crack(Wang et al, 2001). In the Tawarayama
154 Tunnel, most of the longitudinal cracks were the former one(Fig.10a). And length of some
155 longitudinal cracks exceeded dimension of the lining span(about 10 m)(Fig.10b). In addition,
156 a pair of symmetrical cracks were observed at span of S007, and a few non-symmetric cracks
157 occurred at the sidewall at spans of S140, S184 and S188 near the Minami Aso Village. In the
158 Chi-Chi Earthquake, the No. 1 San-I Railway Tunnel, the New Chi-Chi Tunnel on Highway
159 No. 16 and the headrace tunnel of New Tienlun power station were the most representative
160 examples of this type of damage(Wang et al, 2001). And longitudinal cracks also occurred in
161 the Namutani Tunnel in the Great Kanto Earthquake in Japan(Gong, 2007).

Figure 10 Longitudinal crack of concrete lining. (a) longitudinal crack in the Tawarayama

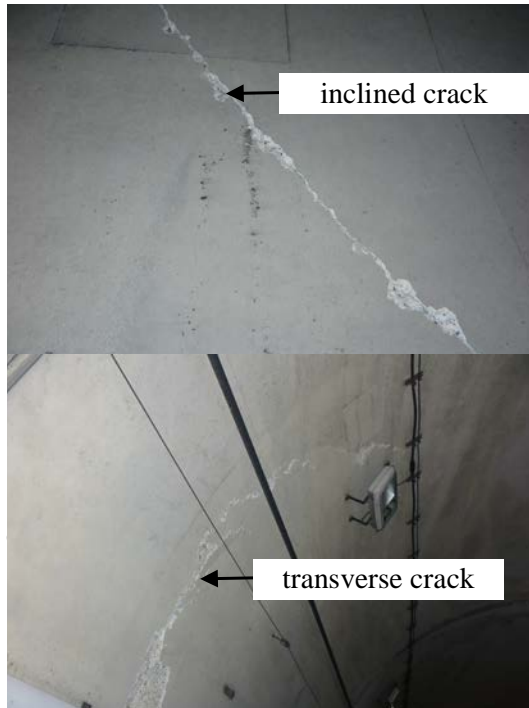
162 Transverse cracks that developed perpendicular to direction of the tunnel axis and inclined
163 cracks with inclination of 40-70° to direction of the tunnel axis were observed to mainly
164 develop at the hance and sidewall, dominated by shearing type and tension-shearing type.
165 Some ring cracks developed from propagation and interaction of transverse and inclined
166 cracks. Both transverse and inclined cracks are illustrated in Fig.11.

Figure 11 Transverse and inclined crack of concrete lining. (a) transverse and inclined crack in the Tawarayama Tunnel; (b) sketch and mapping result of transverse and inclined crack

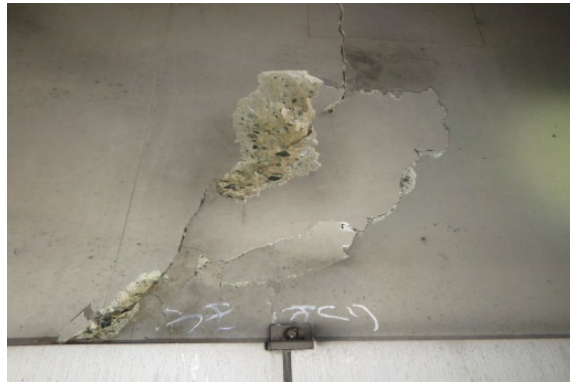
201 Fig.13 shows spalling and collapse of concrete lining in the Tawarayama Tunnel. Concrete
202 lining spalling at the sidewall often developed along with lining cracks, especially inclined
203 cracks(Fig.13a). Besides, large area of secondary concrete lining was observed to collapse,

Figure 13 Spalling and collapse of concrete lining in the Tawarayama Tunnel. (a) concrete lining spalling along with inclined crack; (b) large area vault collapse of crown at spans of S166 and S167;(c) concrete lining fallings

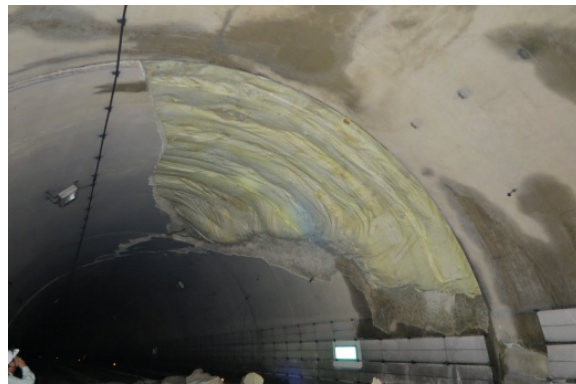
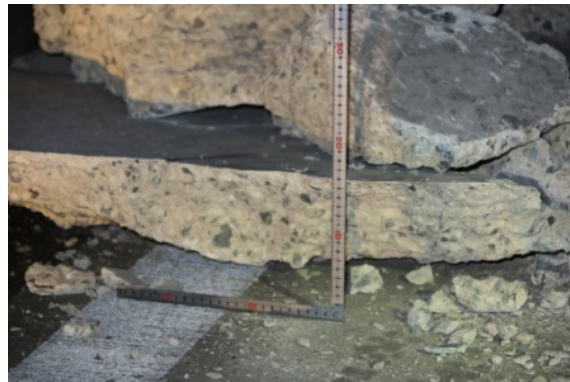
204 especially at spans of S166 and S167(Figs.13b and 13c). In the 1995 Chi-Chi
205 earthquake(Wang et al, 2001) and the 2008 Wen-Chuan Earthquake(Li et al, 2012; Yu et al,
206 2016), lining spalling and collapse were representative seismic damages in numerous
207 mountain tunnels, such as the No. 1 San-I railway tunnel, the Loingxi Tunnel, et al.

219 Geological investigation indicated that loosen zone of surrounding rock existed around the
220 Tawarayama Tunnel along the east slope of the Tawarayama Mountain. And forensic
221 investigation showed that there were gravels in the waterproof at spans of S166 and S167.
222 The loosen surrounding rock and cavity existing behind the lining influenced imperfection of
223 contact between tunnel lining and surrounding rock, leading to spalling of concrete lining,
224 even collapse of tunnel structure. Spans of S166 and S167 are also at the tunnel turning
225 corner(Fig.3), which may result in unexpected seismic response to make these spans
226 vulnerable. Therefore, tunnel sections with turning, sudden changes in form, intersections of
227 two tunnels and emergency parking places, et al., require more attention during the design
228 and construction of tunnel. A large fault was found to exist over the spans of S166 and S167

229 through in-situ investigation, in consistent with the secondary concrete lining collapse.

230 Tunnels that go through fault or shear areas or into a large plastic area are more likely to
231 show collapse. Therefore, for future tunnel planning, efforts should be made to avoid running
232 cross active fault zones or weak surrounding rock where possible. When crossing faults,
233 reinforced countermeasures should be taken into consideration for the concrete lining.

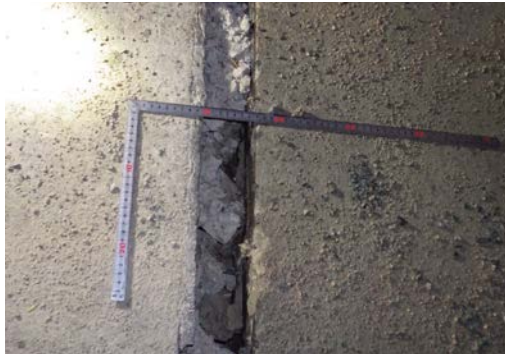
(a)

250 crushed Andesite appear alternately along the Tawarayama Tunnel extending direction, which
251 may lead to transverse fracture and dislocation at the interface between soft and hard rock.
252 Moreover, due to abrupt changes of tunnel cross section or turning of tunnel, stress variation
253 of tunnel is also regarded as one of main causes for tunnel pavement damage. In the present
254 study, spans ranging from S150 to S200 at the turn of the Tawarayama Tunnel were

255 representative examples(Fig.15a).

Figure 15 Different types of pavement damage in the Tawarayama Tunnel.(a) transverse cracking of pavement;(b) maintaining roadway uplift at the left side of maintaining roadway.

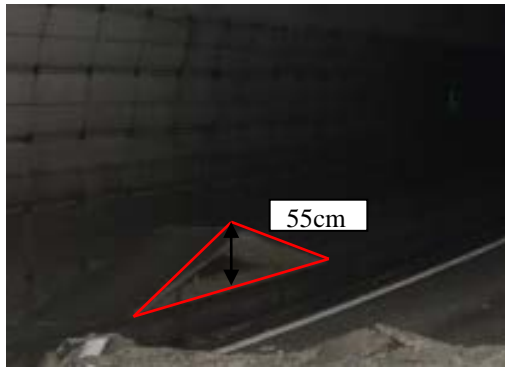
(b)

235 Uplift and cracking of pavement were frequently observed at the portal(S001) of the
236 Tawarayama Tunnel near the Nishihara village. Fig.15 shows pavement damage in the
237 Tawarayama Tunnel. Damage of this pattern can be further classified into three types:
238 transverse fracture and dislocation (maximum opening, 10 cm) (Fig.15a), maintaining
239 roadway uplift(maximum, 55 cm) (Fig.15b), invert uplift(maximum, 20 cm).

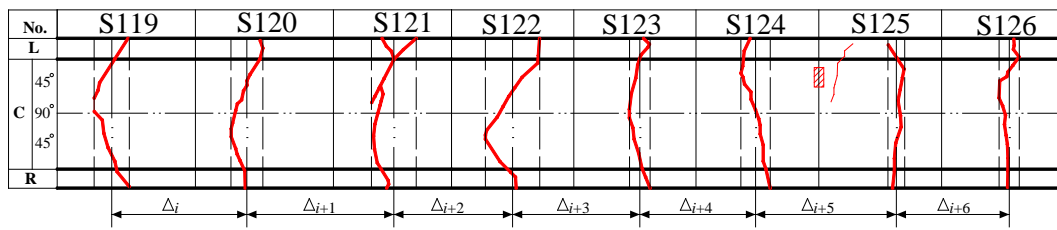
269 A special and interesting phenomenon was observed during site investigation for the
270 Tawarayama Tunnel that 55 ring cracks distributed with a regular spacing Δ in 23.4% spans
271 of the Tawarayama Tunnel. They mainly concentrated in S030~S053, S095~S097,
272 S119~S126, S146~S153, S157~S165, S184~190(Fig.8). Fig.17 provides a further sketch
273 illustration of ring crack distribution and corresponding estimated spacing. Fig. 18 illustrates
274 estimated spacing of the regularly distributed ring cracks in the Tawarayama Tunnel. The
275 spacing was estimated to be about 10.0m.

Figure 17 Sketch of ring cracks in spans from S119 to S126 and corresponding estimated spacing.(*i* denotes the No. of ring crack)
