## GEO- AND HYDRO-MECHANICAL EVALUATION OF SLOPE FAILURE INDUCED BY TORRENTIAL RAINS IN NORTHERN-KYUSHU AREA, JULY 2009

### ABSTRACT

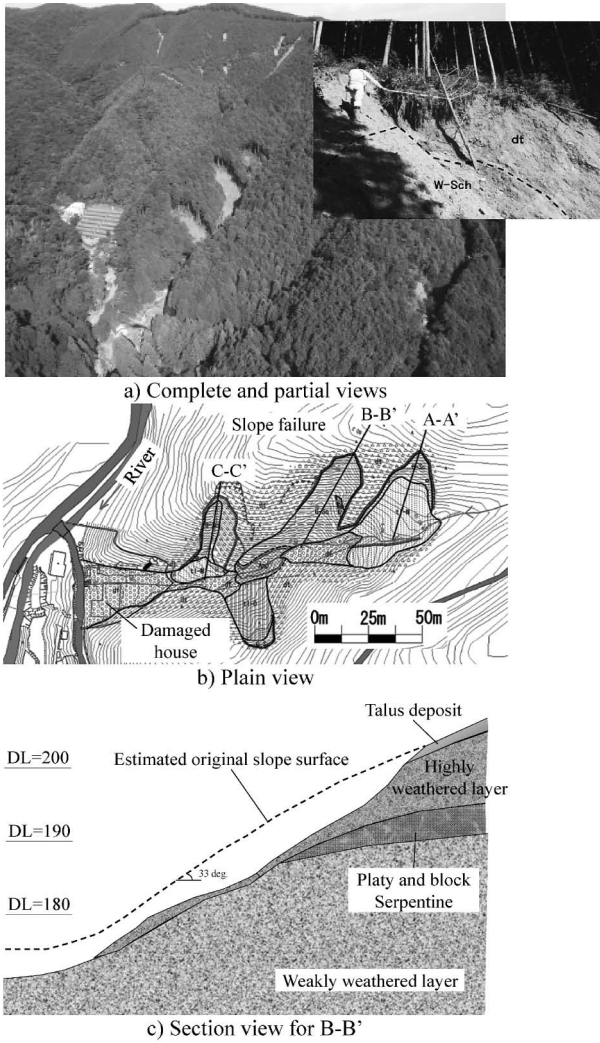
The characteristics of a typical geodisaster, such as slope failure and debris flow induced by the torrential rainfall, are briefly summarized in this section. The slope failures followed by debris flow in Sasaguri-machi, Kasuya-gun, in Fukuoka prefecture are shown in Fig. 4. Three slope failures about 20 m in width and 3–5 m in

depth occurred on the right side along a similar tributary and the collapsed soil mass temporally blocked rainfall. Then, the collapsed soil mass with a large amount of water became a debris flow 100 m in length, and destroyed the homes in its path. Figure 4(c) shows a sectional view of slope failure B. The original slope angle was about 33 degrees, and the surface layer of the slope consisted of a highly weathered weak gravelly clay with a low water content. It is estimated that the collapsed soil mass was 20 m in width, 5 m in depth, 50 m in length and had a total volume of 2400 m<sup>3</sup>, which is larger than the other two slope failures.

Fig. 4. Geodisaster occurred at Sasaguri-machi, Fukuoka

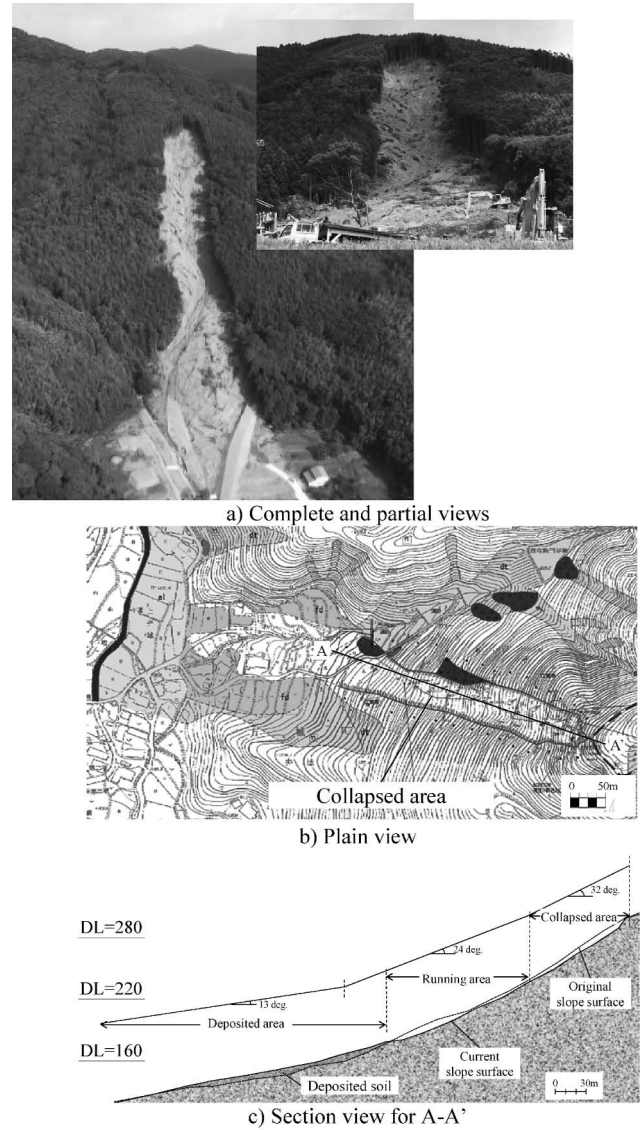
A large debris flow in Fukuchi-machi, in Tagawa-gun, Fukuoka prefecture is shown in Fig. 5. The original slope angle was 24–32 degree. Although the slope of the bed rock was very stiff, the slope surface was highly weathered to around 3 m in depth, which implies it had high failure potential. The debris flow was 50 m in width, 3 m in depth and 400 m in length. The debris flow descended about 160 m in elevation and the head of debris flow crushed houses in its path. The debris flow covered the original slope surface with a layer about 3 m thick.

In the case of both the geodisasters mentioned above, the original slope angle was less than 40 degrees, which is considered to be stable under normal conditions, and a large scale debris flow was induced prior to slope failure.

Fig. 5. Geodisaster occurred at Fukuchi-machi, Fukuoka

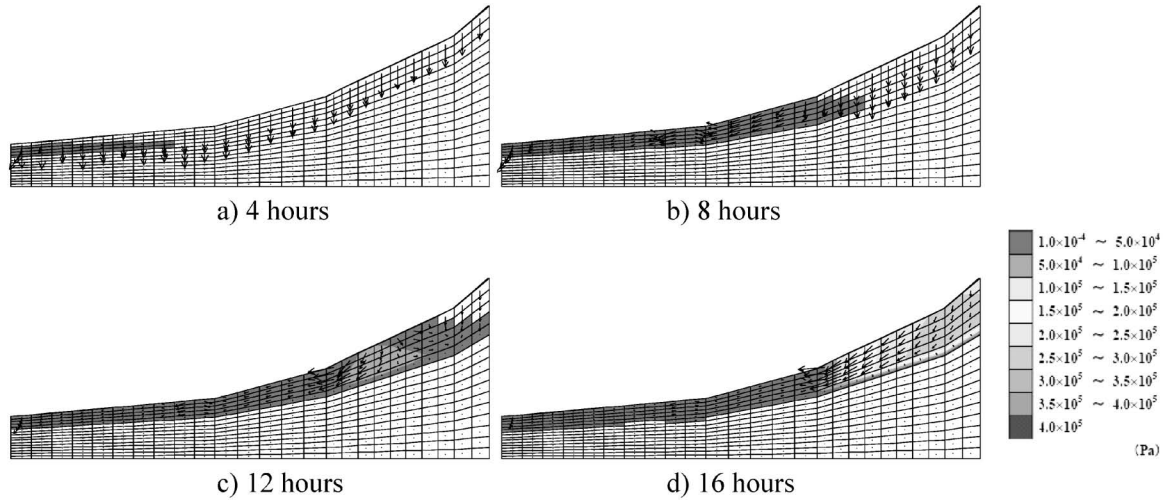
Figure 16 shows the distribution of pore water pressure and the vector of water seepage in the slope after 4, 8, 12 and 16 hours. The vertical seepage in the surface soil layer was remarkable for first 4 hours, and then downward seepage parallel to slope occurred. In addition, the pore water pressure of the surface soil layer accumulated from the lower part to the upper part of the slope as time elapsed.

Fig. 16. The distribution of water pressure obtained by seepage analysis

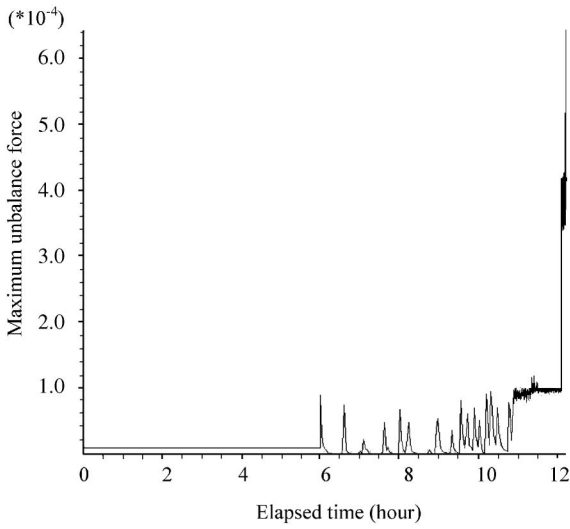
In order to examine the timing of slope failure after the rain started, Fig. 17 shows the maximum unbalanced force ratio against the elapsed time obtained by the stability analysis. The term "unbalanced force ratio" refers to the ratio of driving force and soil resistance for the soil element. The magnitude of maximum unbalanced force ratio was shown to have increased sharply at 12 hours, indicating that large slope deformation occurred at this moment. Figure 18 shows a deformed mesh, with distributions of horizontal displacement and shear strain in the slope at 12 hours. Considerable deformation was observed in the surface soil mesh near the top of slope and shear strain was generated in surface soil layer, which indicate that shallow slope failure occurred and triggered a debris flow. It can be confirmed that torrential rainfall induced large pore water pressure near the top of slope despite the low slope angle, and this was an influential factor, triggering slope failure followed by debris flow. In order to examine the detailed mechanism of the slope failure, however, the mesh near slope surface needs to be refined and the effect of the boundary conditions, such as the leaky boundary just below the slope failure, need to be clarified. This needs to be done in order to properly characterise the soil-water characteristics and the non-linear response of the soil.

Fig. 17. Maximum unbalance force against elapsed time

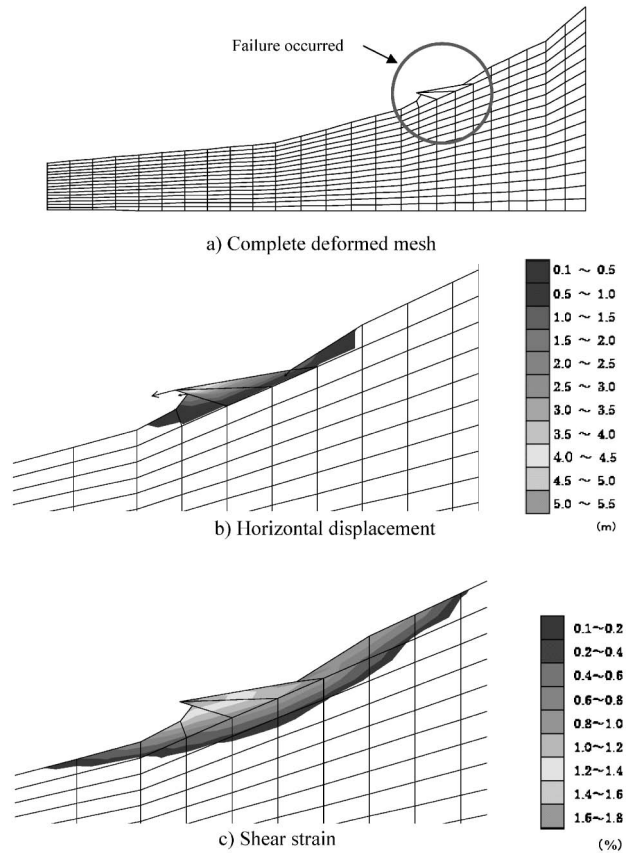
Fig. 18. The results of stability analysis

Based on the results of the slope deformation and stability analyses to simulate geodisaster at Fukuchi-machi, which took changes in the water pressure and cohesive strength into account, it is expected that shallow failure near the top of the slope occurred due to torrential precipitation about 100 mm per hour, which triggered debris flow.
