## **Observation of the embolus protection filter for carotid artery stenting**

Kentaro Hayashi M.D.,<sup>1</sup> Naoki Kitagawa M.D.,<sup>1</sup> Minoru Morikawa M.D.,<sup>2</sup> Takeshi Hiu M.D.,<sup>1</sup> Yoichi Morofuji M.D.,<sup>1</sup> Kazuhiko Suyama M.D.,<sup>1</sup> Izumi Nagata M.D.<sup>1</sup>

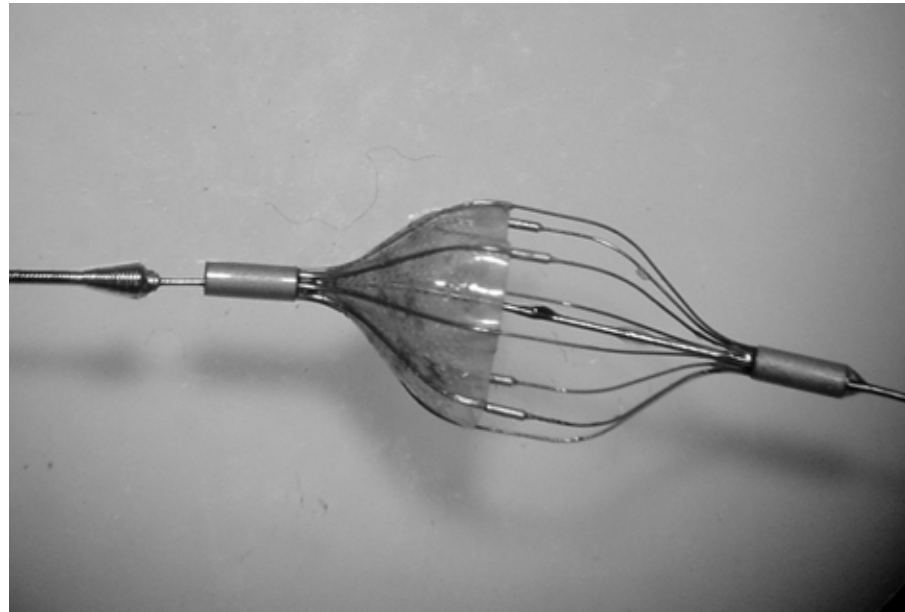
A

A: embolus protection filter

Larger piece of debris were visible by the naked eye. After brief washing with distilled water, the filter was placed Mayer's hematoxylin solution for 1 minutes, and then placed in eosin for another 1 minute with brief wash in between procedures (Fig. 1A). Subsequently, the filter membrane was cut off from the strut and mounted onto a glass slide using paramount (Fig. 1B). Finally, the hematoxylin & eosin (HE)-stained debris on the filter could be visualized using light microscopy. The subtype of debris was classified and the area covered with plaque debris or thrombotic material was measured with NIH image.

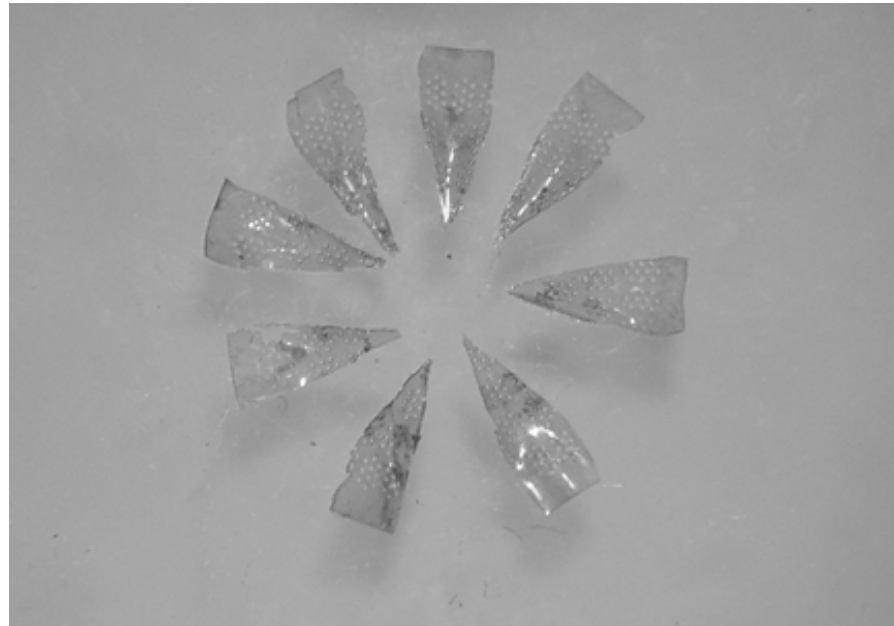
B

B: Removed filter membrane

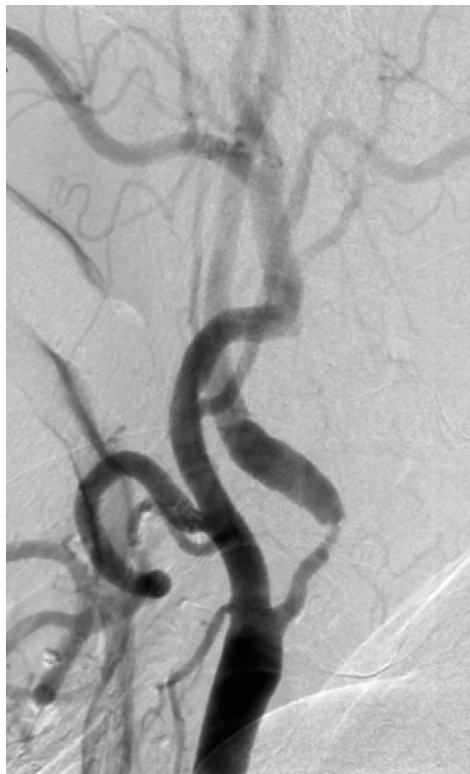
A: Lateral view of the angiography showed high-grade stenosis at the origin of the left internal carotid artery.

A 80-year-old man (Case 9) who had a history of hypertension and hypercholesterolemia presented our hospital because of left amourosis fugax. Angiography showed high-grade stenosis at the origin of the left internal carotid artery (ICA; Fig. 2A). The stenotic lesion was demonstrated as high-density lesion with CT angiography and was graded as severe calcification (Fig. 2B). High-resolution MRI showed isointensity plaque, indicating stable plaque (Fig. 2C). CAS was performed for the left ICA stenosis using embolus protection filter. Self-expandable stent was placed into the left ICA following predilation (Fig. 2D). Intraprocedural angiography showed impairment of blood flow i.e. slow flow phenomenon. The debris containing blood stasis was removed with aspiration catheter and the flow was restarted retrieving the filter. Postprocedural control angiography showed excellent widening of the stenosis (Fig. 2E). The filter membrane was examined and the covered area was measured as 63.7% (Fig. 2F). Hypermagnification of the debris demonstrated irregular hard debris categorized as organized debris (Fig. 2G). Thus, hypermagnification of the filter membrane showed thrombotic material to the pore or numerous cells adhesion to the membrane (Fig. 2H).

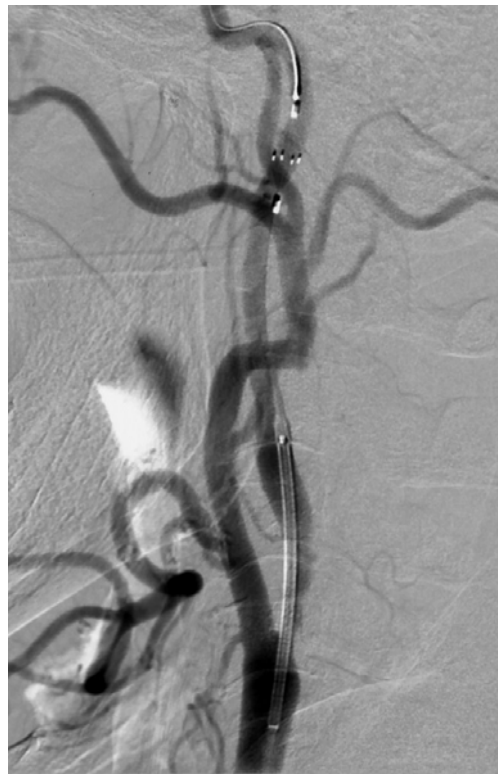
D

D: Angiography after embolus protection filter and stent navigation.

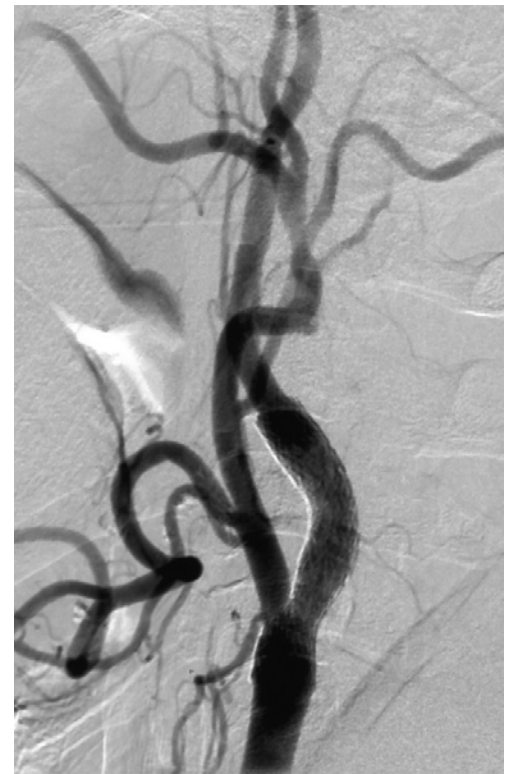
E

E: Angiography after balloon angioplasty and capturing the filter showed satisfactory widening of the stenosis.

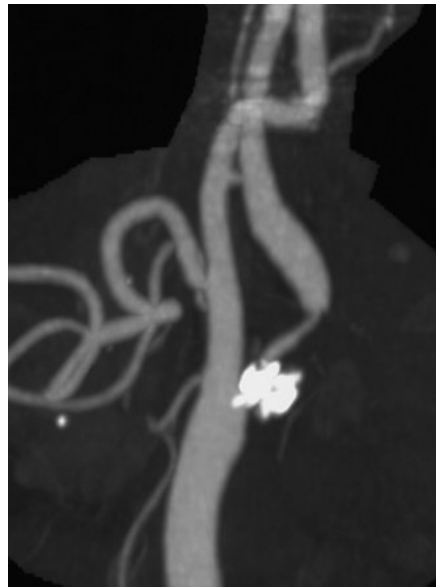
B

B: CT angiography demonstrated high density lesion at the stenosis, indicating severe calcification.

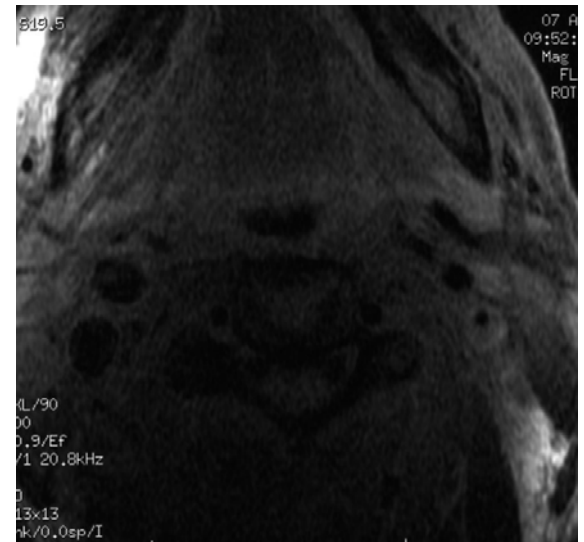
C

C: The plaque was demonstrated as isointensity with high-resolution T1 weighted MRI (arrow).

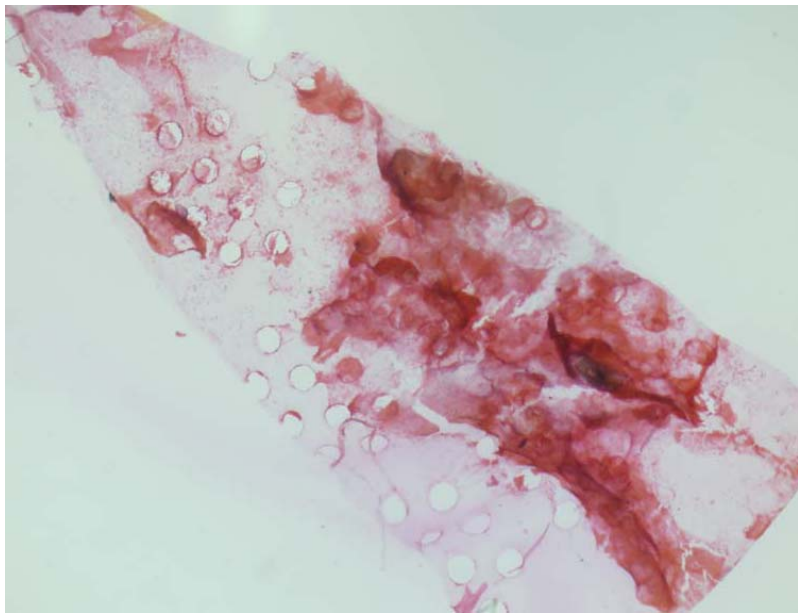
F

F: Microscopical observation of the embolus protection filter.

The pore (100  $\mu\text{m}$ ) allows for quantitative determination of the debris size.

Original magnification X 25 (F), X 100 (G), X 200 (H).

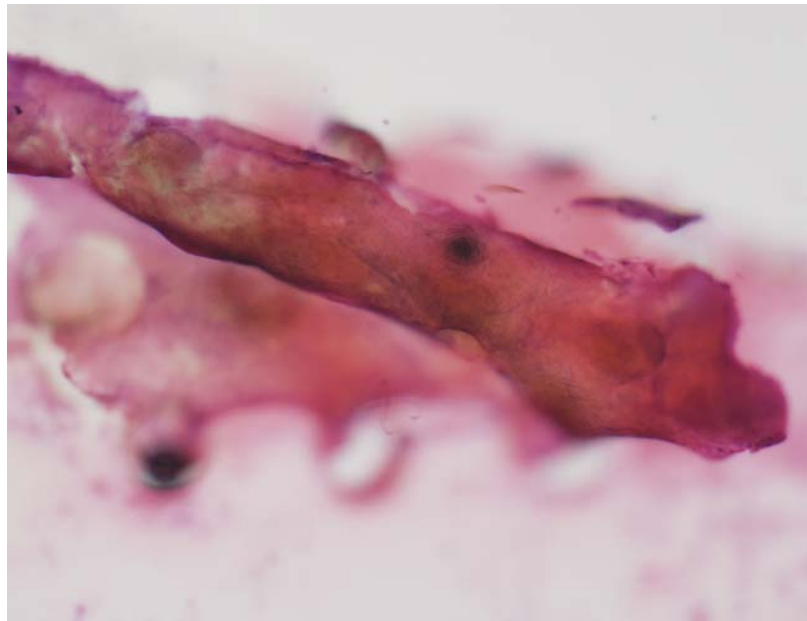
G

G: Organized debris

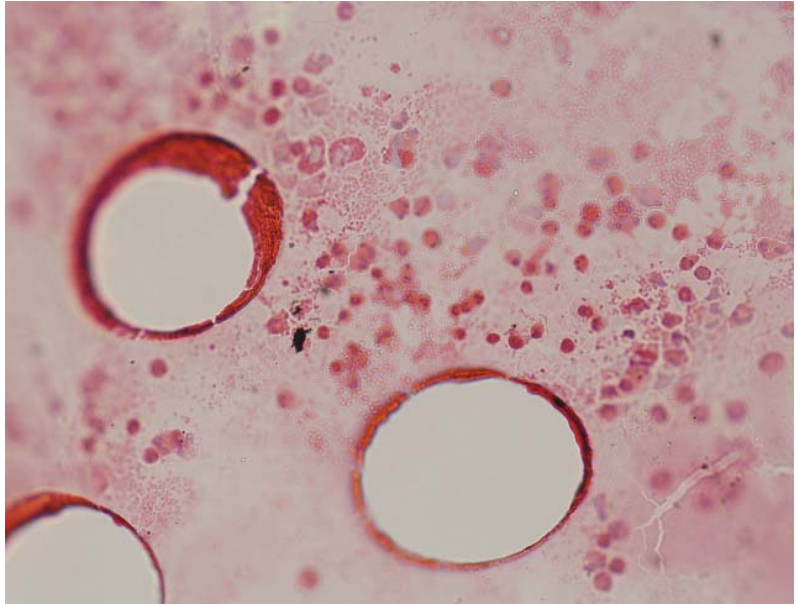
H

H: Blood cells adhesion to the membrane.

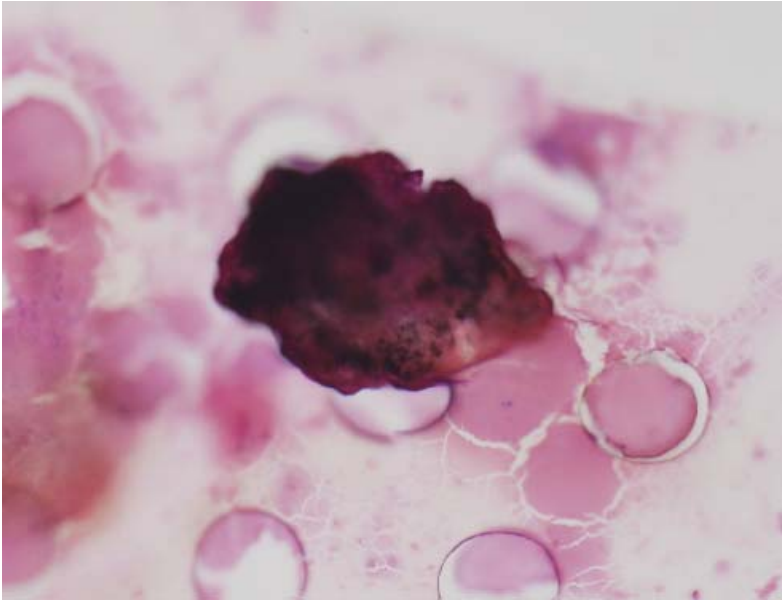
A

A: Lipid rich debris

Original magnification X 100.

abundance of lipid-rich debris, which was soft and yellowish, was revealed on the embolus protection filter (Fig. 3A). Postoperative diffusion weighted MRI showed multiple hyperintensity lesion, indicating shower embolism. In radiation induced stenosis, high resolution MRI showed isointensity lesion, which indicated stable plaque. Under microscope, fusiform cells with fibrous tissue were identified in the debris and was categorized as fibrous debris (Case 5; Fig. 3B). Calcified debris, which was hard and stained with hematoxylin, was dominant in the material from hyperechoic lesion (Fig. 3C). And thrombotic debris stained with eosin was seen in the heterogeneous echoic lesion (Fig. 3D).

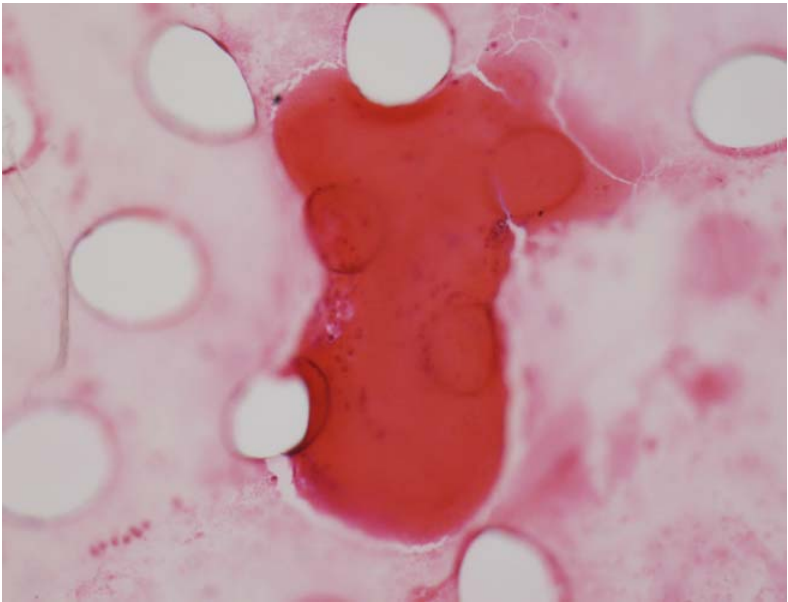
B

B: Fibrous debris

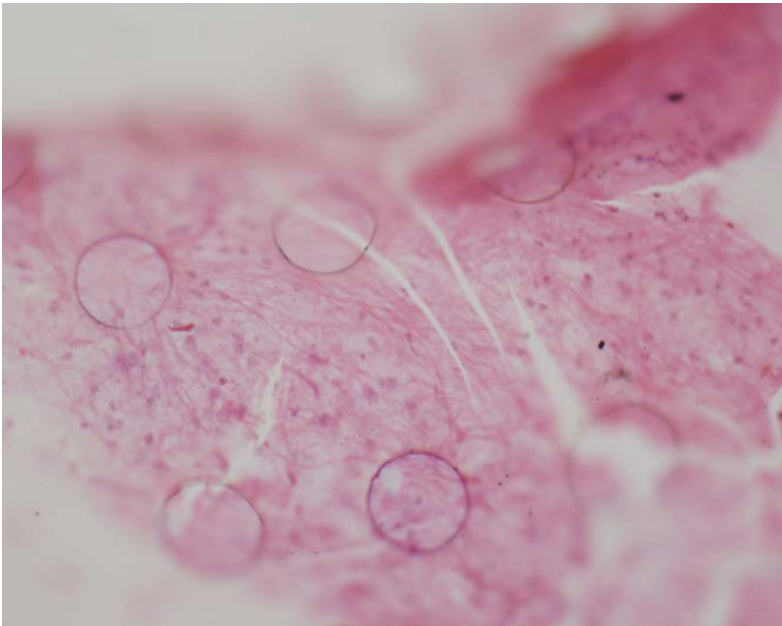
C

C: Calcified debris

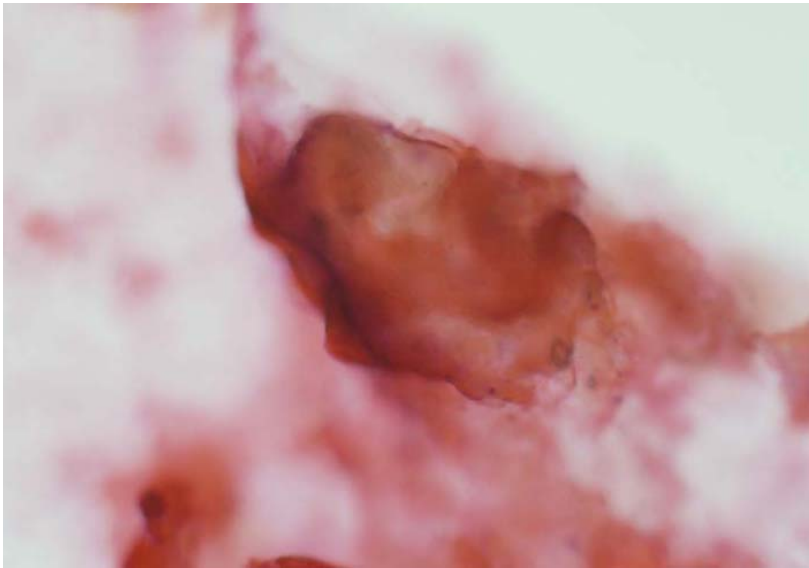
D

D: Thrombotic debris
