# UAV を用いた阿蘇大橋落橋の解析

## Analysis of Aso Big Bridge Collapse with UAV

Yukiya TANIGUCHI\*, Susumu OGAWA\* and Shuntaro OTSUBO\*\*

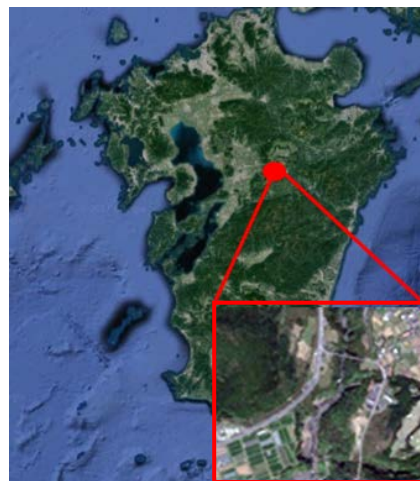
Fig. 1 Satellite images of the Tatsuno hill in South Aso.

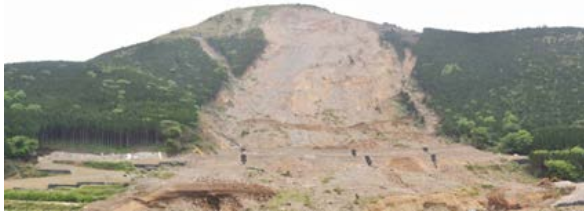
Fig. 2 Horizontal Image of collapsed Aso Big Bridge  
(May 8, 2017).

On April 14, 2016, a large earthquake with magnitude 6.5 occurred in Kumamoto Prefecture. The depth of the epicenter was 11 km [1]. On April 16, 2016, strong shakes with magnitude 7.3 and more than intensity 6 continued in Kumamoto city and the surrounding municipalities [2]. The depth of the epicenter was 12 km [1]. Landslide collapse occurred frequently in South Aso by the Kumamoto earthquake. Aso Big Bridge collapsed [2]. The aerial image of the Tatsuno hill where Aso Bridge existed and the horizontal image of the falling bridge are shown in Figs. 1-2. Landslides and cracks of the earth occurred frequently

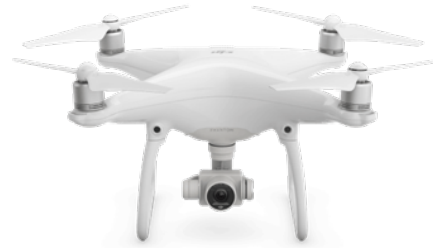
Fig. 3(a) Phantom 4.

Phantom 4 and Phantom 4 Professional were used in this study (Figs. 3(a)-(b)). On May 28 and June 11, 2016, and May 8, 2017, the authors visited Aso Big Bridge in South Aso and took the aerial images of Aso Big Bridge collapse. In 2016, the images were acquired using manual navigation. On the other hand, in 2017, the images were obtained with

Fig. 3(b) Phantom 4 Professional.

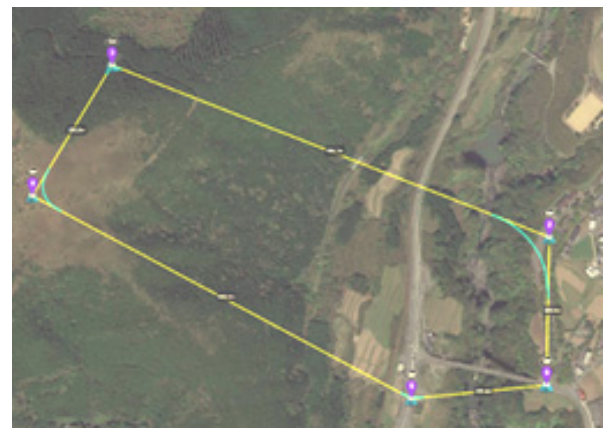
Fig. 4 Route map of UAV using *Litchi for DJI Mavic / Phantom / Inspire*.

automatic navigation. The routes of the automatic navigation were created using *Litchi for DJI Mavic / Phantom / Inspire*. The route map is shown in Fig. 4.

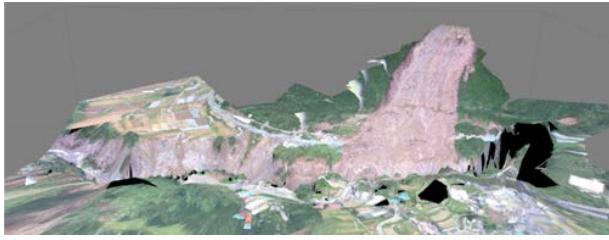
Fig. 5(a) 3D model of Aso Big Bridge by manual navigation.

Two 3D models are shown in Figs. 5(a)-(b). Fig. 5(a) shows a 3D model with manual navigation. The collapsed slopes and the central river passing through the north to the south were synthesized. Mountainous areas, rice paddies, and corners of the images showed some cavities. Fig. 5(b) shows another 3D model with automatic navigation. There were no small holes scattered, but one cavity was formed at the top of the slope.

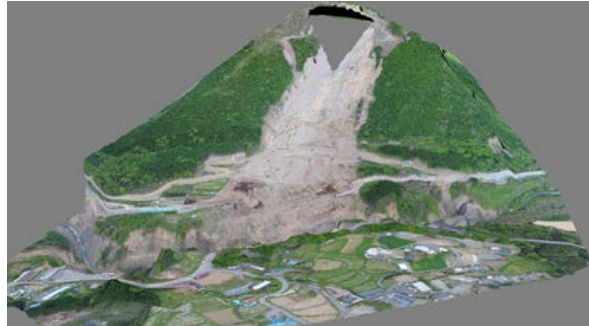
Fig. 5(b) 3D model of Aso Big Bridge by automatic navigation.

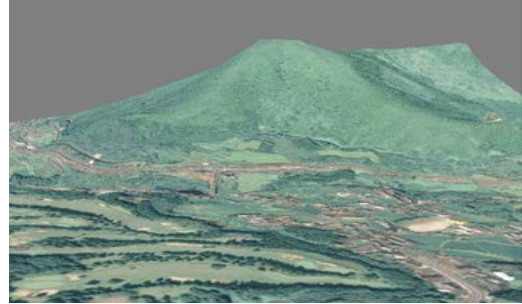
Fig. 6(a) 3D model of Aso Big Bridge and the original Tatsuno hill from GIAJ (2013).

Fig. 6(a) shows a 3D model of the Tatsuno hill and Aso Big Bridge in 2013. Fig. 6(b) shows a bird-eye-view of the Tatsuno hill and Aso Big Bridge in 2013. They were created from two aerial images of Geospatial Information Authority, Japan.

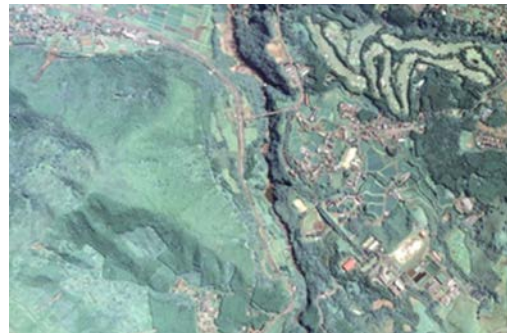
Fig. 6(b) Bird's eye view of Aso Big Bridge and the original Tatsuno hill from GIAJ (2013).

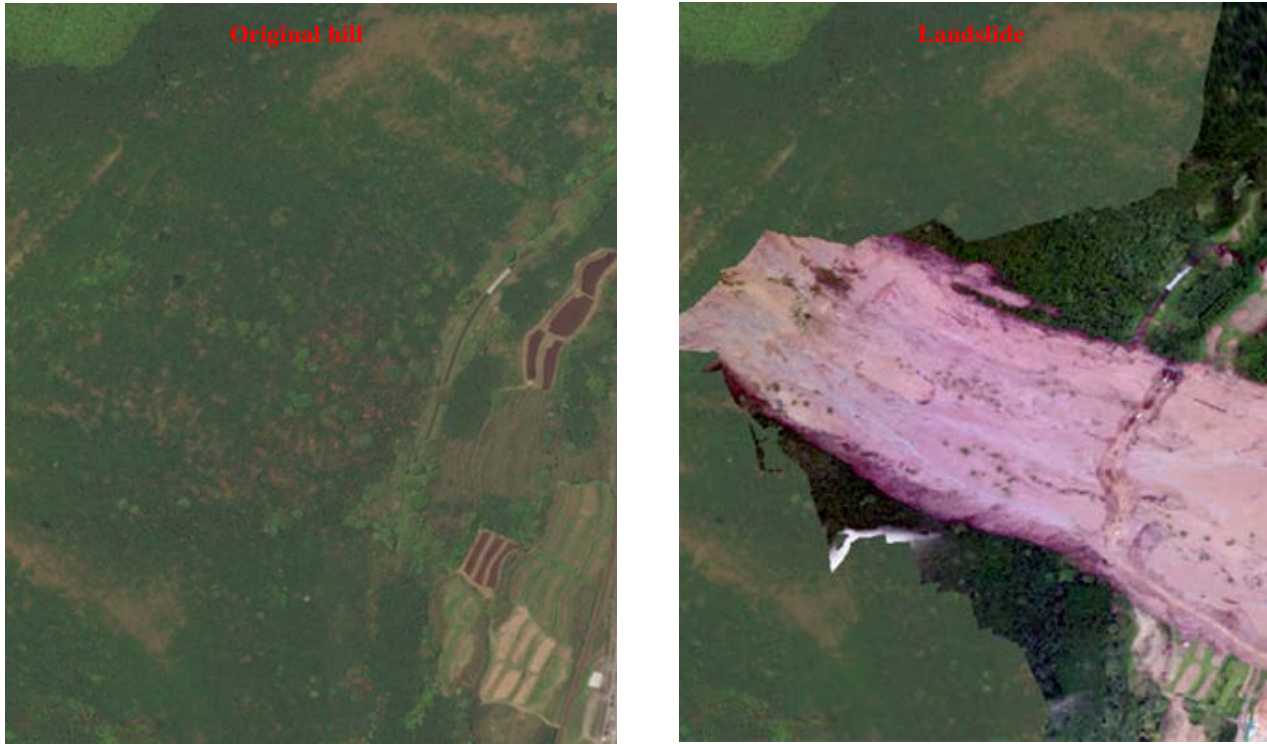
Fig. 8 West slopes of Aso Big Bridge (The original hill and after landslide).

The collapse spatial distribution of Aso Big Bridge was calculated using ArcGIS, as shown in Fig. 7. Fig. 8 shows enlarged slope views of the Tatsuno hill before and after the landslide. Fig. 9 shows a DSM map and contour lines with 10-m intervals after the landslide. Furthermore, an up-and-down distribution of sediments is shown in Fig. 10. Fig. 10 was calculated from after-landslide-DSM

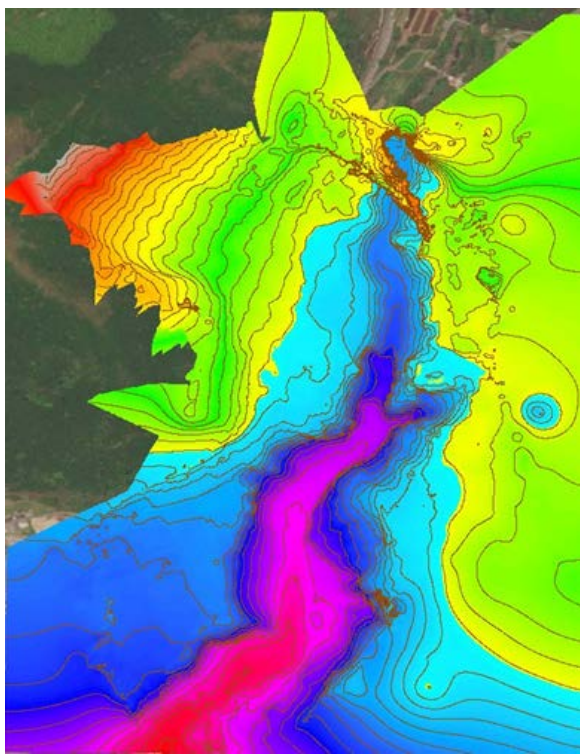
Fig. 9 DSM and contour distributions around Aso Big Bridge.

In Fig. 9, the elevation of landslide area decreased 10-30 m from the adjacent hill without damages. In Fig. 11(c), no change points in height was estimated to be sediments of the same height as trees were deposited on the place where a forest were lost. The elevation near A' increased. Sediments by the landslide were accumulated on the original hill. The biggest collapse occurred at the top of the slope. Considering the height of trees, the estimated deepest scraping was approximately 40m. According to the research

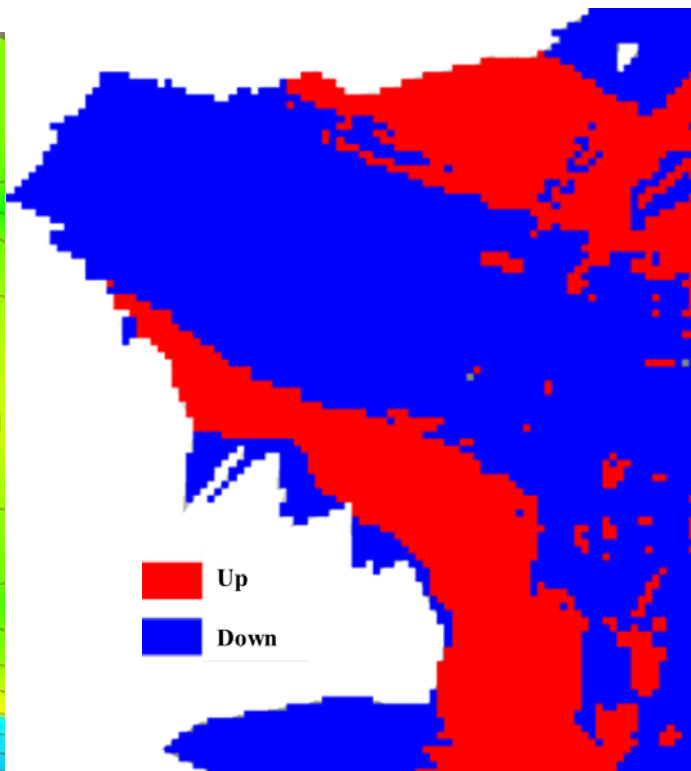
Fig. 10 Up and down distributions of displacement of the Tatsuno hill.

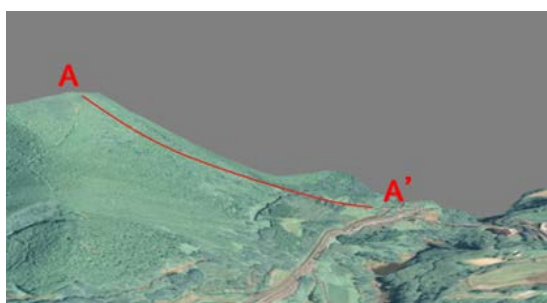
Fig. 11(a) Original profile of the Tatsuno hill.

images from UAV and the original hill DEM images by the Geospatial Information Authority, Japan. A profile of the original hill and another profile of after landslides is shown in Figs. 11(a)-(b). A landslide profile graph comparing both the original hill and after landslide is shown in Fig. 11(c). From Fig. 11(c), the number of major collapse points in this landslide were four. Furthermore, the estimated landslide volume was 250,000 m<sup>3</sup> from Geospatial Information Authority, Japan DEM data with 10 m/pixel spatial resolution and UAV- DSM data with 14.7 cm/pixel spatial resolution.

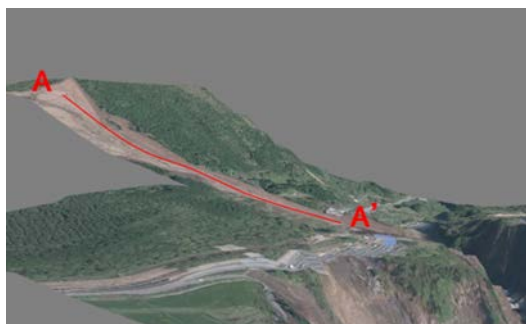
Fig. 11(b) Landslide profile of the Tatsuno hill.

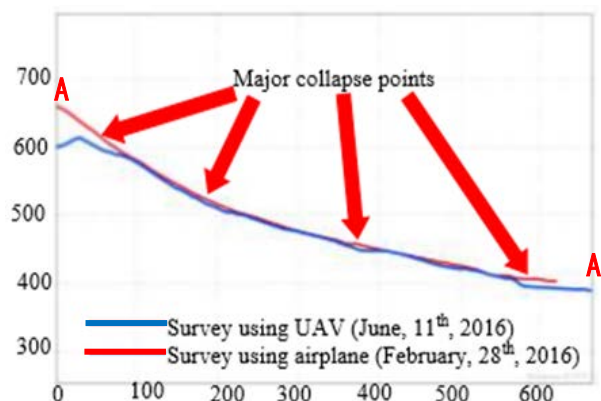
Fig. 11(c) Original and landslide profiles of the Tatsuno hill.

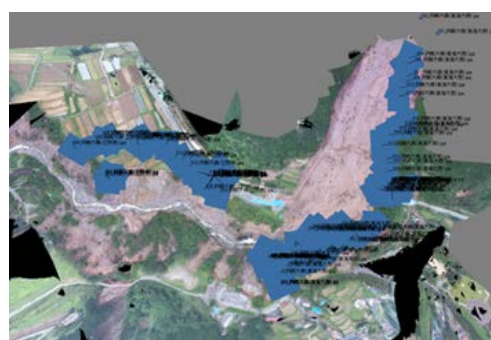
Fig. 12(a) Shooting position of the manual navigation.

In Fig 12 (a), when checking the aerial image of UAV, the images of landslide parts and the river in the center were taken more than other parts. When constructing a 3D model, PhotoScan concentrated on the synthesis of the river and collapse areas. This shooting was not unified to the camera direction. The overlap of some parts was less than 60%. These problems tended to occur in manual navigation. In Fig. 12(b) with automatic navigation, the highest area images could not be obtained because the width of UAV routes was too wide. However, the intervals of photograph points were constant. Other images were nothing. Automatic navigation would be a useful tool in

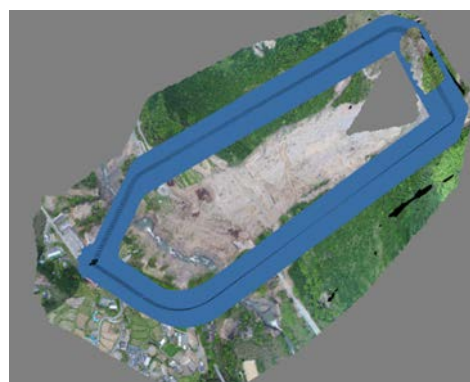
Fig. 12(b) Shooting position of the automatic navigation.
