A case of iliac artery injury treated by covered stent during carotid artery stenting

Kentaro HAYASHI M.D., Nobutaka HORIE M.D., Ichiro SAKAMOTO M.D.*, Minoru MORIKAWA M.D.*, Izumi NAGATA M.D.

Department of Neurosurgery, Nagasaki University School of Medicine

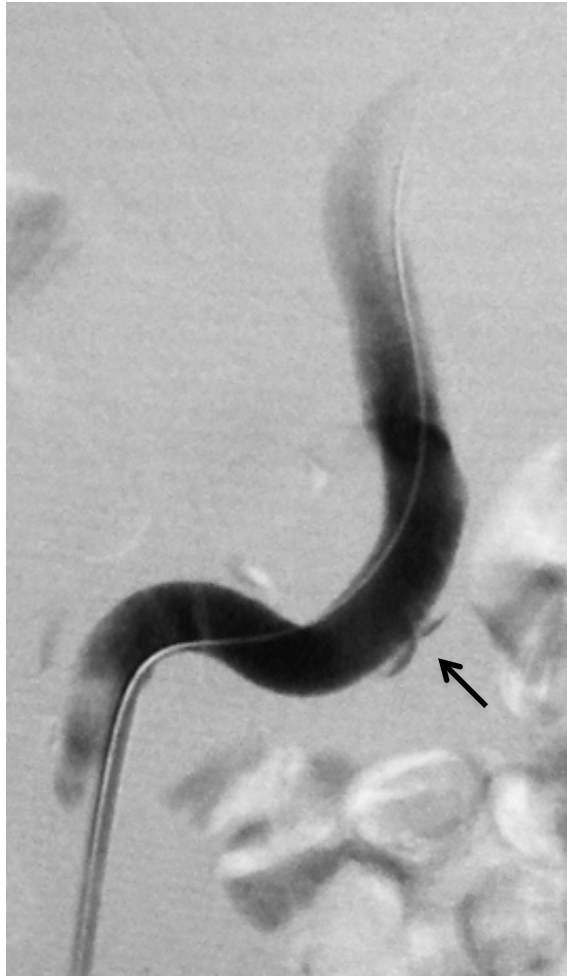
A

A: After placement of sheath introducer, dissection at the elongated iliac artery was revealed (arrow).

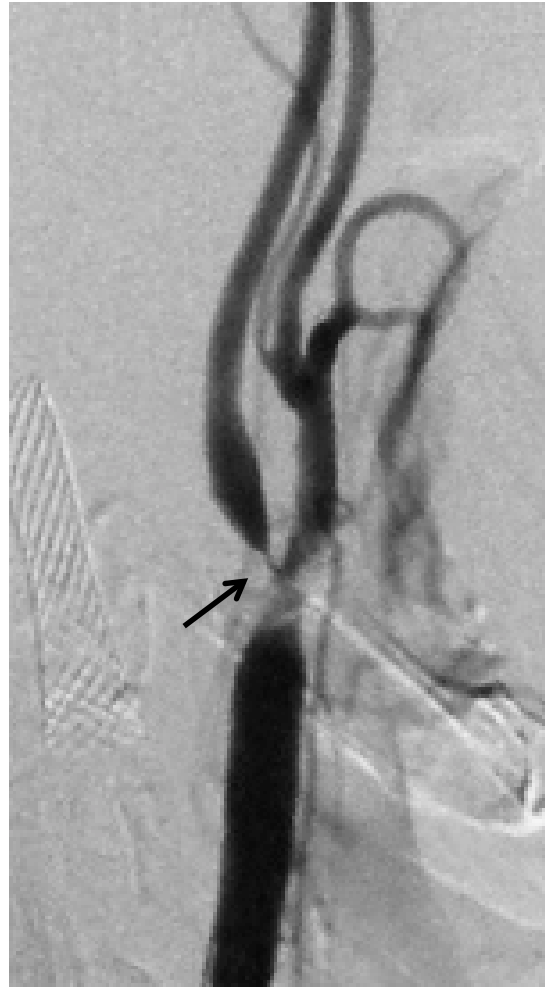
B

B: High-grade stenosis was seen at the origin of the right internal carotid artery (arrow).

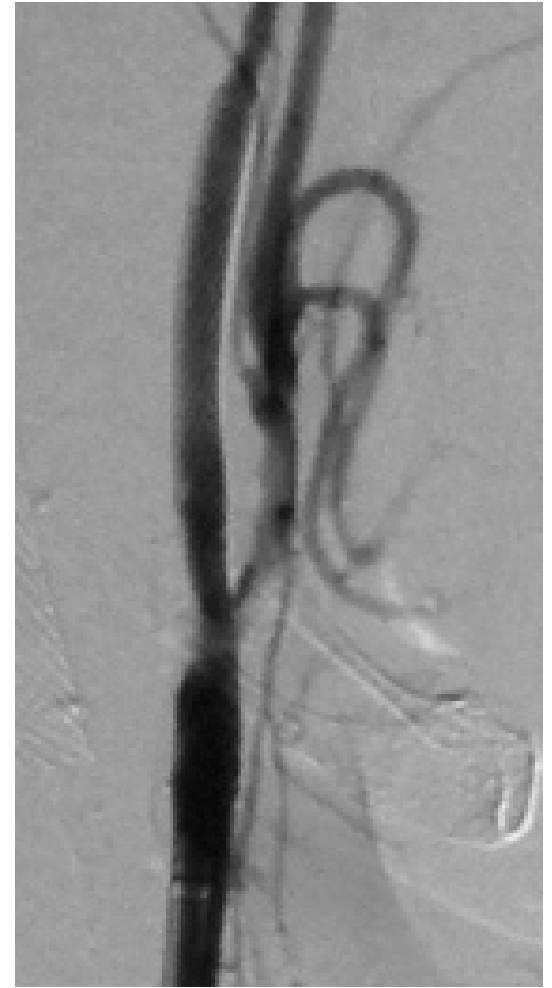
C

C: After placement of stent, the stenosis was satisfactory dilated.

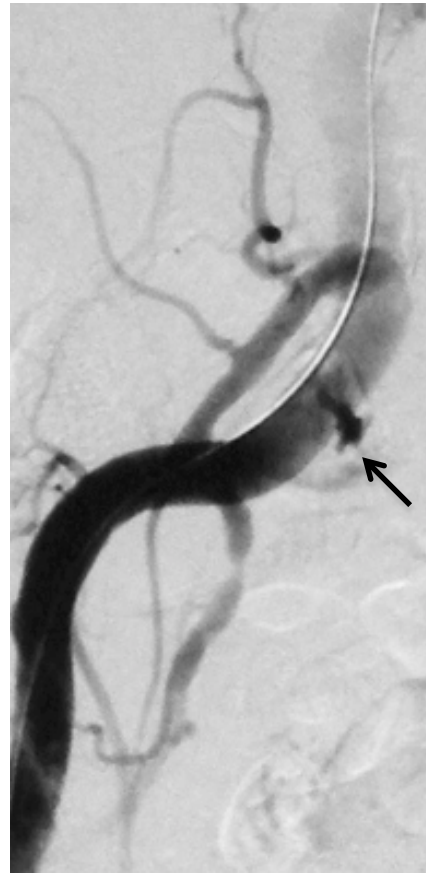
F

F: After temporary balloon occlusion, extraversion of the contrast medium still continued (arrow).

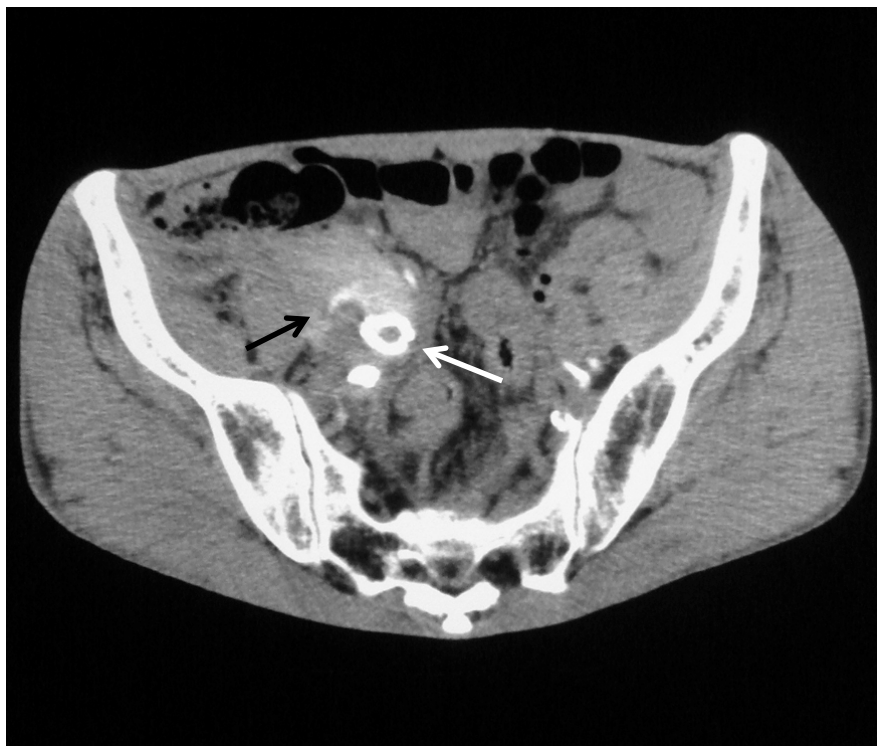
Fig. 2 Postoperative examination

Abdominal CT shows stent at the iliac artery (white arrow) and retroperitoneal hematoma (black arrow).

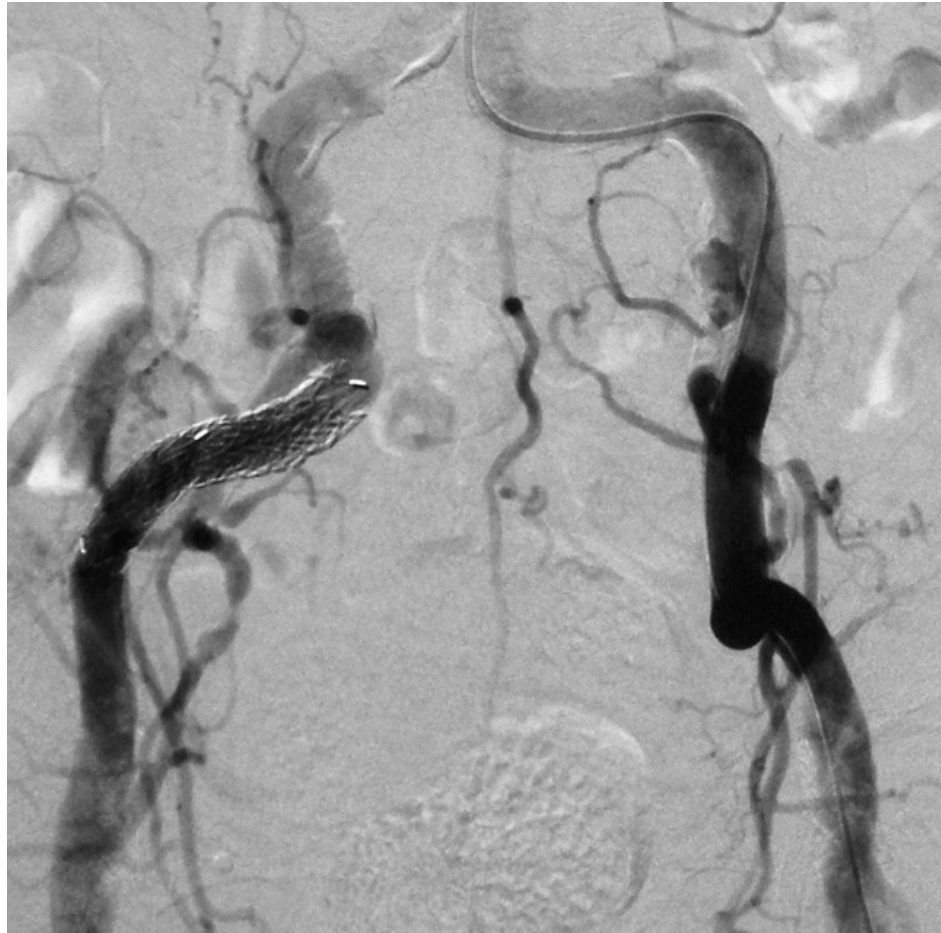
Fig. 4 Follow-up angiography

The patency of the covered stent was excellent two years later.

After implantation of the covered stent, long-term follow-up is needed because of restenosis. Antiplatelet oral therapy was required [3]. After 2 years of prescription of dual antiplatelet therapy, patency of the covered stent was excellent in this case.
