## The July 1997 Landslide Disaster at Harubun, Sasebo, Japan

Keinosuke GOTOH and Minoru YAMANAKA

Faculty of Engineering, Nagasaki University  
Bunkyo-machi, Nagasaki 852-8521, Japan

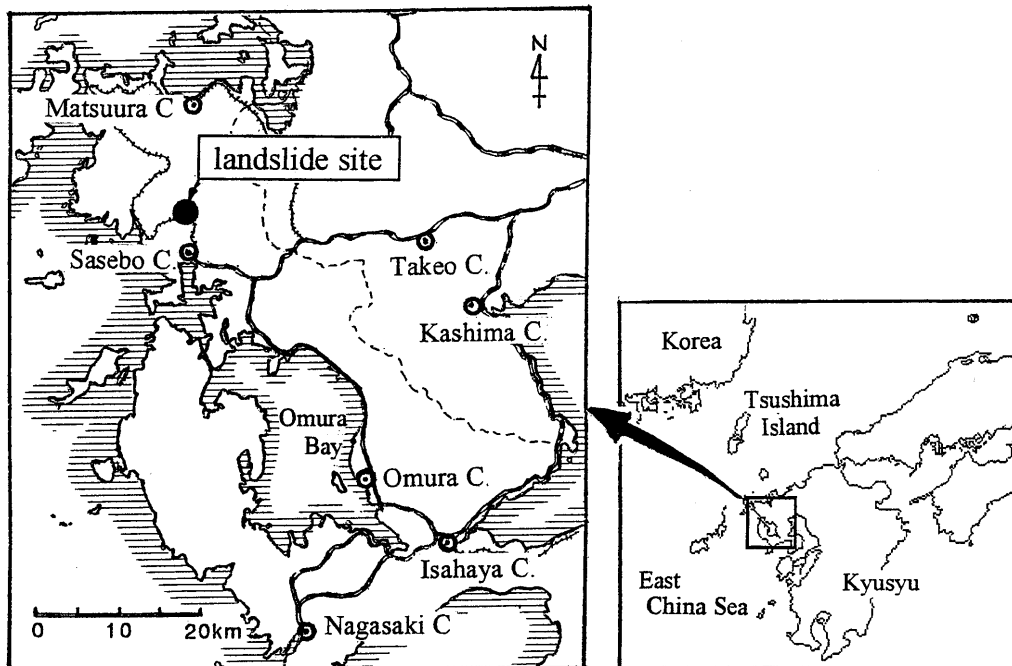
Fig. 1. Site of the landslide.

Figure 1 shows the location of the landslide at Harubun-cho, Sasebo City, and the outline of the sliding is shown with detailed topography in Fig. 2. The landslide took place on a gentle hillslope in a landslide-prone area where many potential landslides have been predicted topographically (Nagasaki Pref. Forestry Consultant Co., 1987).

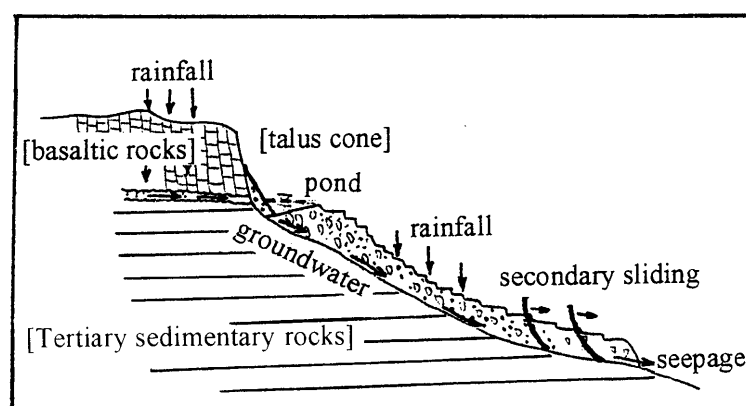
Fig. 4. Schematic diagram showing the sliding of a Hokusho-type landslide (Modified after Yamasaki, 1966).

Figure 4 shows a schematic sketch of secondary sliding in a Hokusho-type landslide (Yamasaki, 1966). It occurred in the basalt erosional layer, and frequently along the gentle slope on the glide erosional layer. When rain water reaches the gravel layer of the basalt plateau through the joints within the basaltic rocks, it gushes out at ground surface as seepage. As this usually is followed by softening of the ground, the procedure is called the first landslide. After a first landslide, because of the seepage of rain water inside the soil a second landslide is likely to happen.

The landslide type described in this paper can be classified as the secondary sliding of a Hokusho-type landslide.
