## GEO- AND HYDRO-MECHANICAL EVALUATION OF SLOPE FAILURE INDUCED BY TORRENTIAL RAINS IN NORTHERN-KYUSHU AREA, JULY 2009

### ABSTRACT

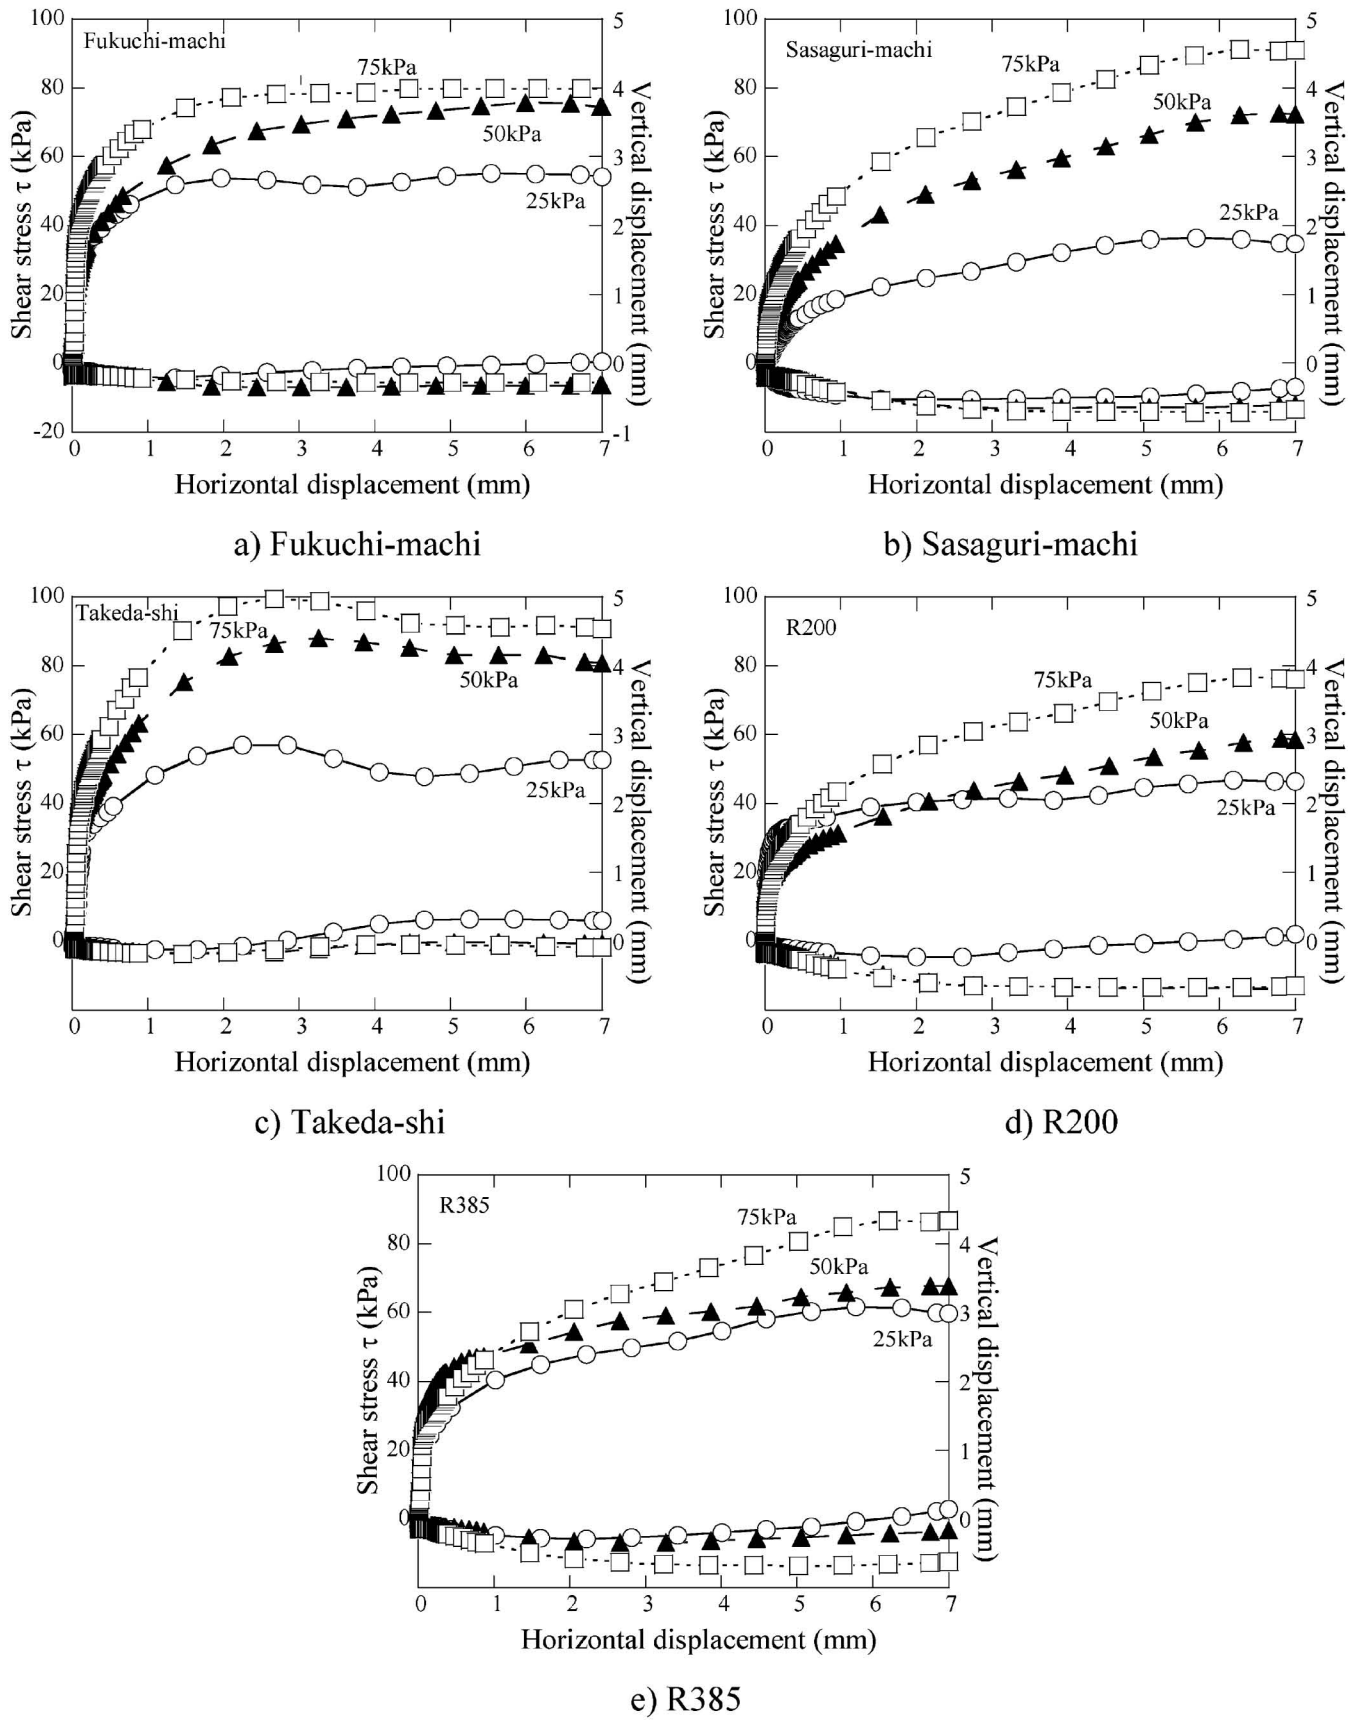
Fig. 8. Shear stress and vertical displacement against horizontal displacement under constant vertical stress

Figure 8 shows the shear stress and the vertical displacement against horizontal displacement. It can be seen that all soil samples except for the Takeda-city sample showed a monotonous increase in the stress-displacement behavior with volumetric compression similar to normally consolidated clay and loose sand. Taketa-shi sample shows that there was a peak in shear stress around the horizontal displacement of 2-3 mm, which was similar to stress-strain behavior of overconsolidated clay. The failure criteria are shown in Fig. 9. As all soil samples were in the unsaturated condition, it can be determined that there is was an intercept in the failure criteria derived from the suction force between soil particles. The friction angles of Sasaguri-machi, Takeda-city and R385 samples

were over 40 degrees, while the cohesions of Fukuchi-machi and Takeda-city samples were 45.7 kPa and 30.9 kPa, respectively. The relatively high shear strength of the collapsed soil with the natural water content is relatively large, making it reasonable to suggest that collapsed slopes were originally stable enough not to be considered prone to slope failure. In order to examine the changes in the strength properties of collapsed soils due to water seepage of rainfall into the slopes, a series of consolidated constant pressure direct box shear tests was carried out for Fukuchi-machi and Sasaguri-machi samples with a water seepage process. In the water seepage process, the de-aired water was drained from the bottom of the specimen in the shear box for 30 minutes before the consolidation process. The consolidation pressures were 25 kPa and 50 kPa. Figure 10 shows the shear stress and the vertical displacement against horizontal displacement for Fukuchi-machi and Sasaguri-machi specimens due to the water seepage process. Figure 11 shows the friction

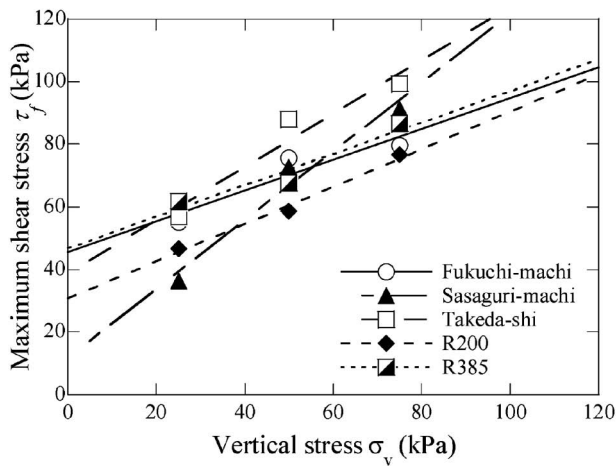
Fig. 9. Failure criteria of collapsed soil

angle and cohesion for Fukuchi-machi and Sasaguri-machi samples with/without the water seepage process together with the test results for the Takeda-shi, R200 and R385 specimens, as shown in Fig. 9. In addition, the test results for the collapsed soils taken from prior geodisaster sites in the Kyushu area (see the investigation report produced by Kyushu Branch of JGS, 2010) are also shown in the figure. The friction angle for the Fukuchi-machi specimen increases by about 10 degrees while the cohesion decreases by about 30%. In the case of the Sasaguri-machi, the friction angle drastically decreases, by about 60%. Consequently, the shear strength for any given initial vertical stress for Fukuchi-machi and Sasaguri-machi specimens drastically decreases due to the decrease in cohesion (loss in suction) resulting from soil saturation cause by water seepage. The decrease in the strength parameter due to water seepage in this experiment, however, was shown to be de-

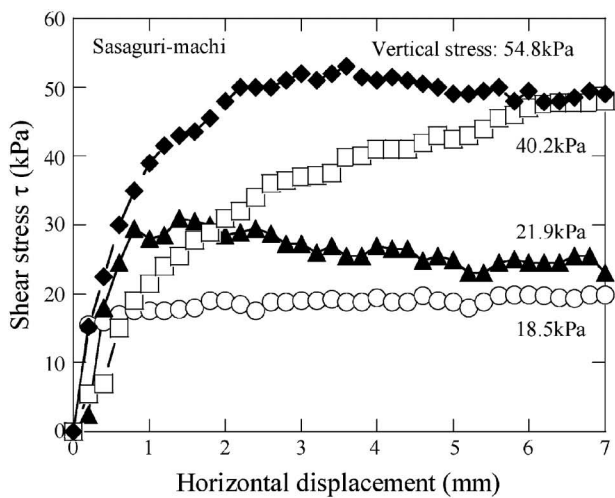
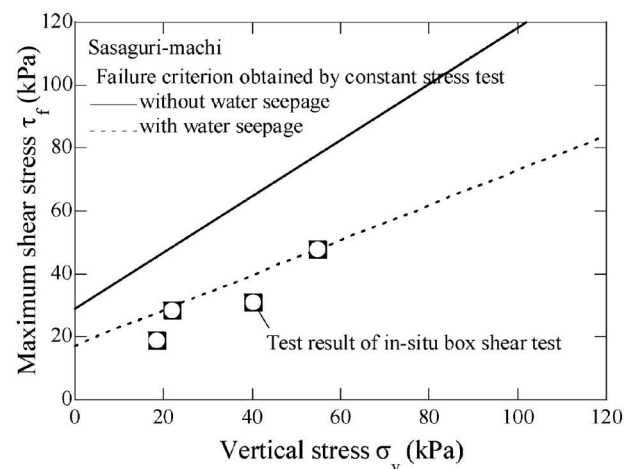
**Fig. 14. Test results of in-situ box shear test**

In addition to a series of direct box shear tests, an in-situ shear test was carried out on the slope failure at Sasaguri-machi in order to examine the applicability of the in-situ shear test for estimating the in-situ shear strength at the field. The test apparatus for the simplified in-situ box shear test used in this investigation was originally developed by Yamamoto et al. (2001). The specimen for this test apparatus is 60 mm in diameter and 20 mm in height, and is trimmed and shaped from the original slope by hand. The vertical stress of the specimen depends on the amount of pressure applied by the human sample-taker. Figure 14(a) shows the shear stress against horizontal displacement obtained by the in-situ box shear test. It can be seen that there is a monotonic increase in shear stress with horizontal displacement, indicating that the in-situ soil is in a loose condition and the maximum shear stress increases as the vertical stress increases. Figure 14(b) compares the failure criteria for the Sasaguri-machi slope obtained by the in-situ box shear test and the consolidated constant pressure direct box shear test with/without the water seepage process. The test results of the in-situ box shear test are close to the failure criteria with the water seepage process. Further investigation is required to evaluate the applicability of the simplified in-situ box shear test.
